Subj: (U) REPORT OF THE INVESTIGATION INTO THE FACTS AND
CIRCUMSTANCES SURROUNDING THE ACCOUNTABILITY FOR, AND
SHIPMENT OF, SENSITIVE MISSILE COMPONENTS TO TAIWAN

FINAL REPORT

INVESTIGATION INTO THE SHIPMENT OF SENSITIVE MISSILE COMPONENTS TO TAIWAN (U)

MAY 22, 2008

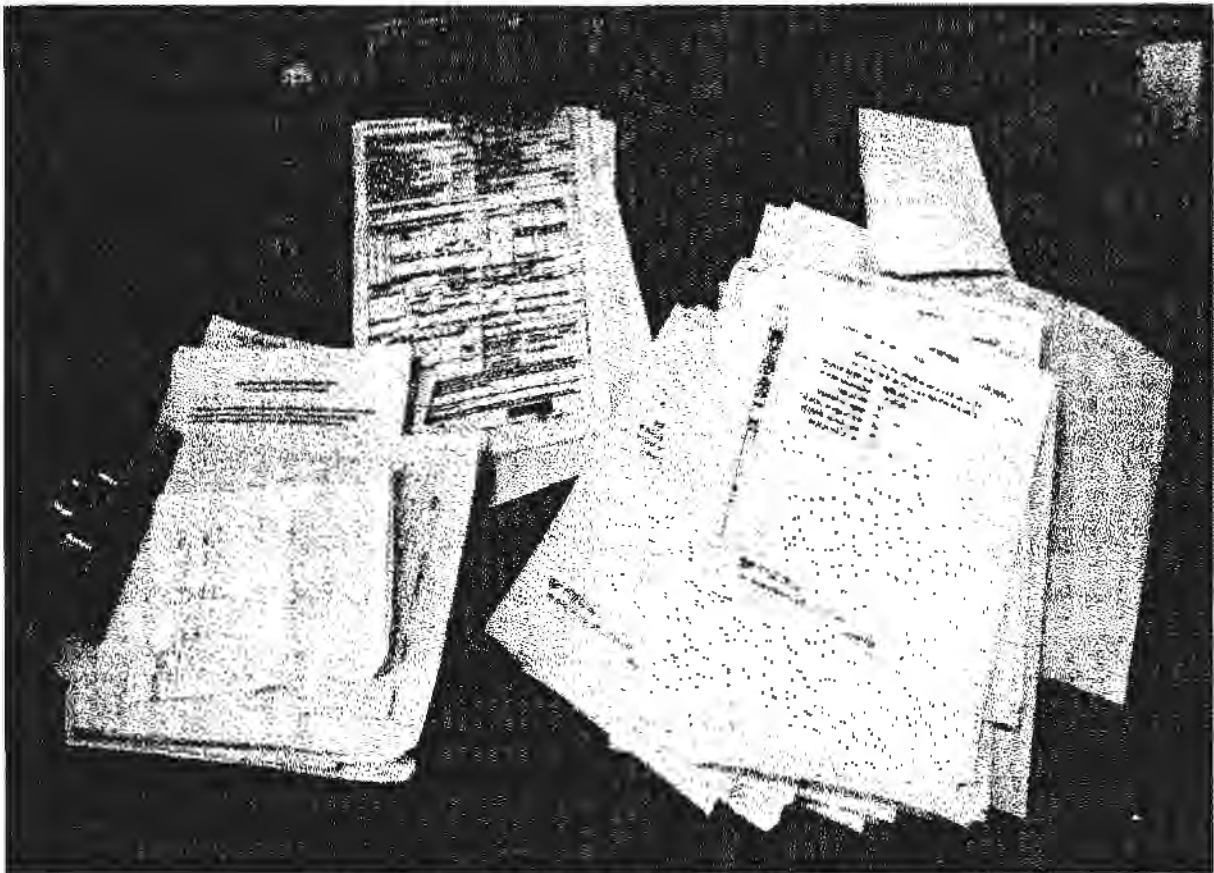
Figure 2 – DDHU REPSHIP File (U)

(c) (U) DDHU's file of REPSHIPS for pending classified receipts was not organized by date or auditable. Further, it was not purged to reflect shipment arrivals (see Figure 2 below). The condition of the file limited its effectiveness in confirming receipt of and maintaining control over classified shipments.
