SUBJECT: Emergency and Extraordinary Expense Request - Kunduz Hospital (U)

Project Title: Kunduz Repair Hospital

According to the given instruction, ATS team creates this report as a final product. This report indicates mandatory information that presents (MSF) Hospital of Kunduz, the Update / actual plans, site photos, existing facilities and existing Utility condition. The following details are guides for more assistance and well understanding of this report which are:

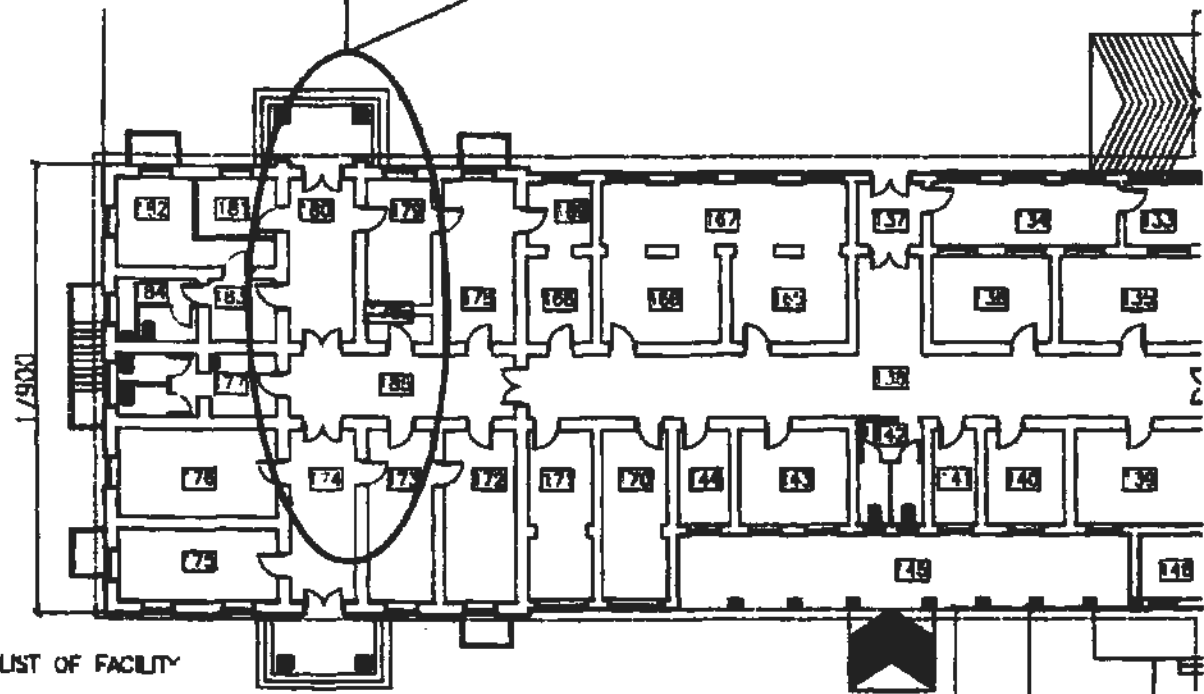
Information: The building Section, wing A & C areas are completely burned out and destroyed. All walls, ceramic tile floors, roof, ceiling, PVC windows and PVC doors destroyed and burned.

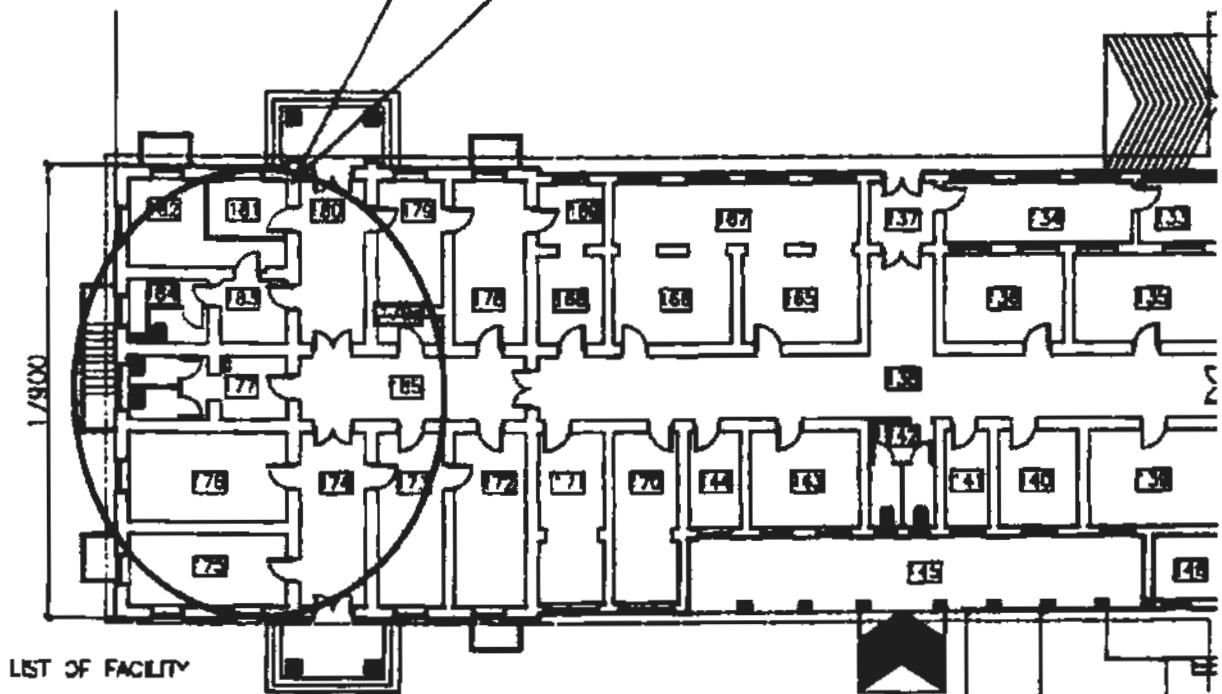
Information: The building Section A and C areas are completely burned out and destroyed.

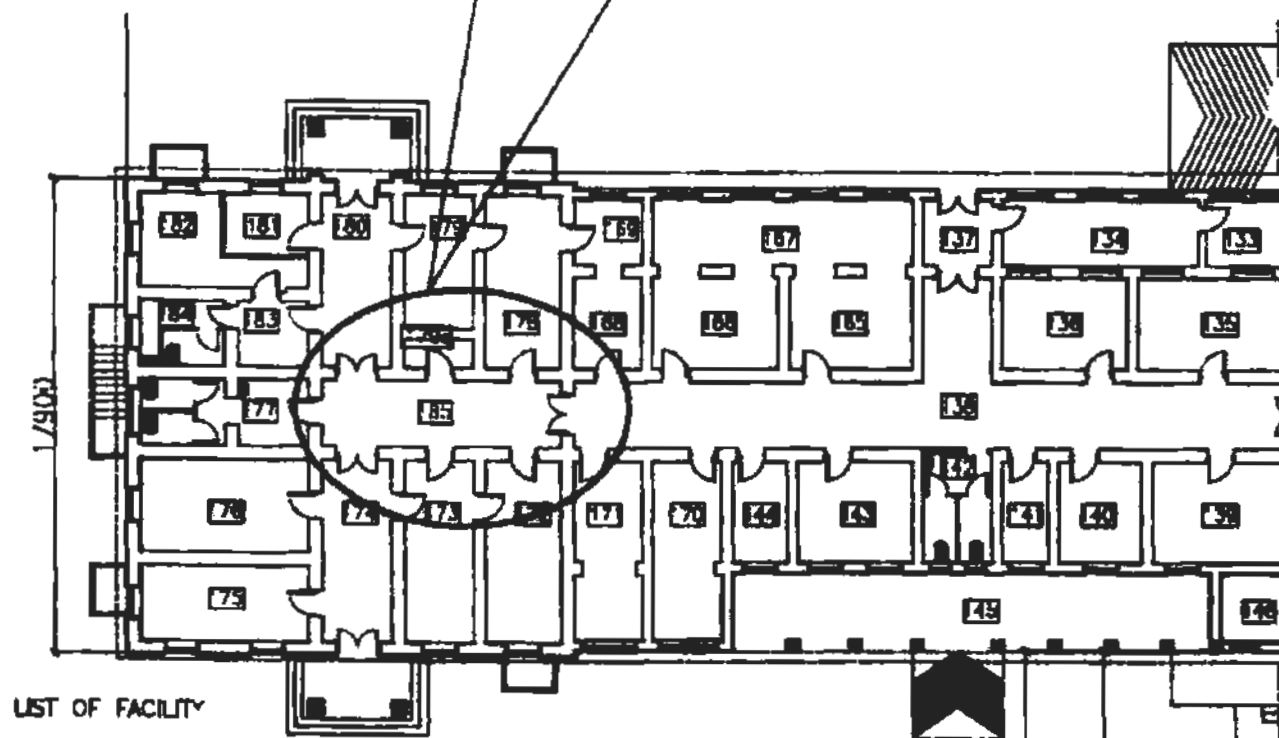
Information: The roof of Wing /section A and C of the main building is completely destroyed and burned.

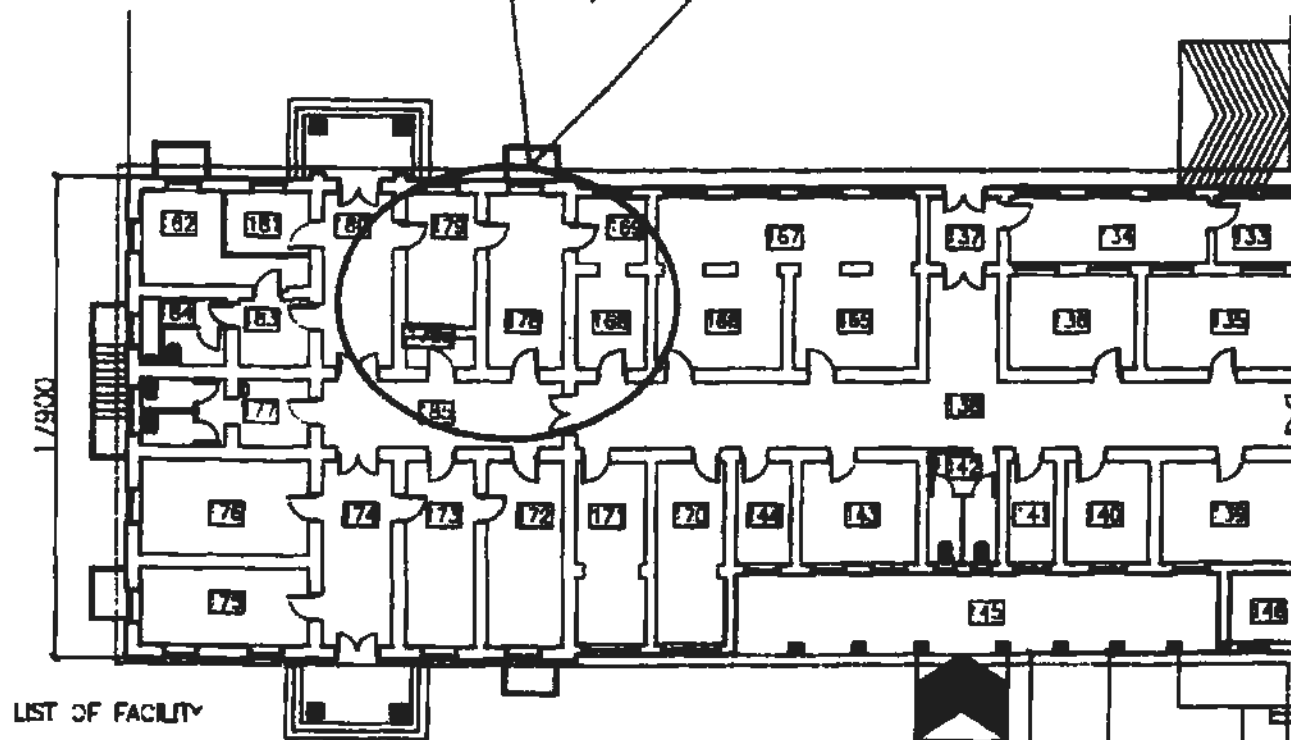
Information. The inside of the first floor building was previously divided by brick masonry partition walls that after the accident all the walls burned and destroyed.

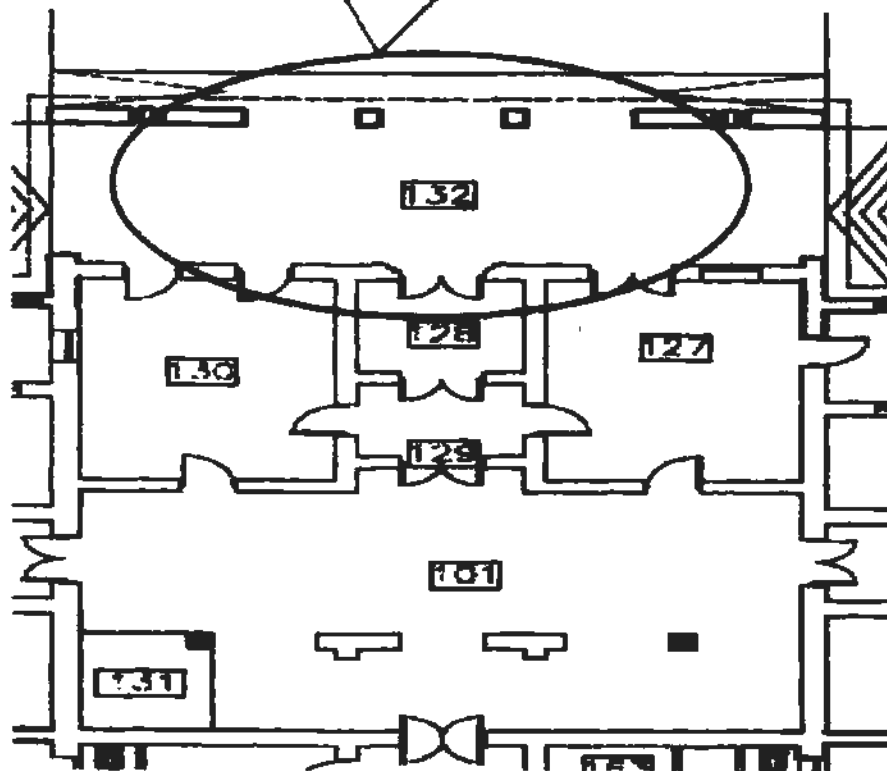
Kunduz MSF Hospital, Main Entrance:
Information: No wall, ceramic tiles floor, roof, ceiling, PVC windows and PVC doors are repairable and operational because all damaged and burned.

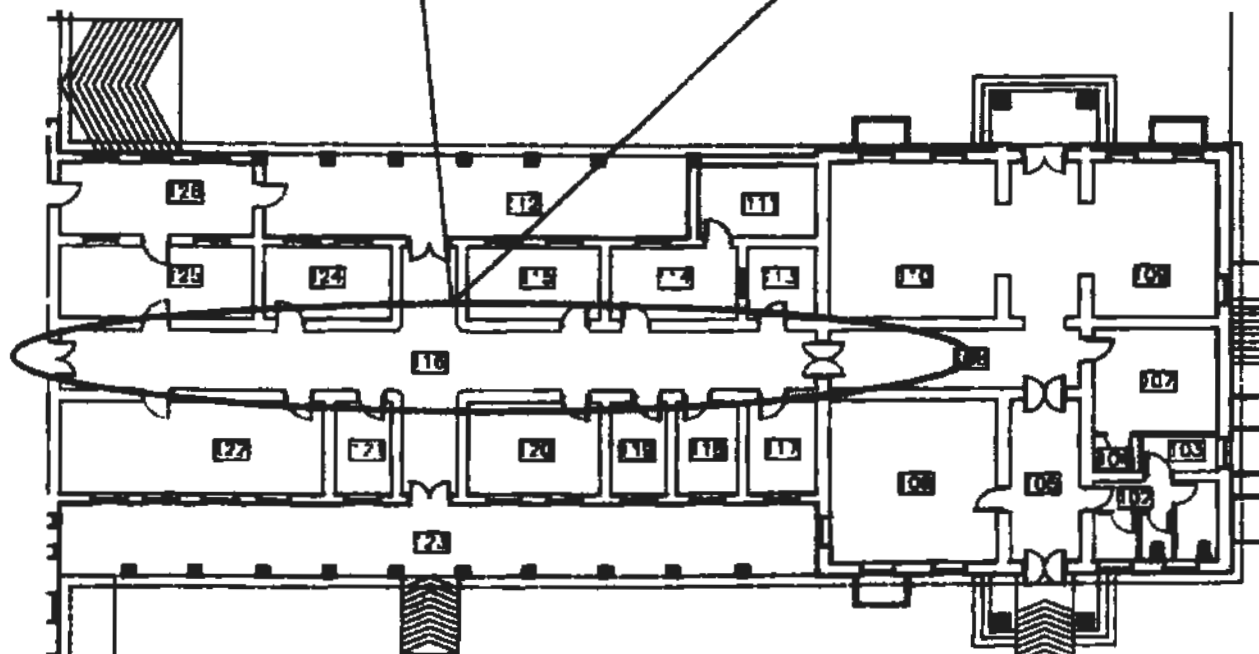
Information The building Section A and C areas are completely burned out and destroyed. All walls, ceramic tile floors, roof, ceiling, PVC windows and PVC doors destroyed and burned.

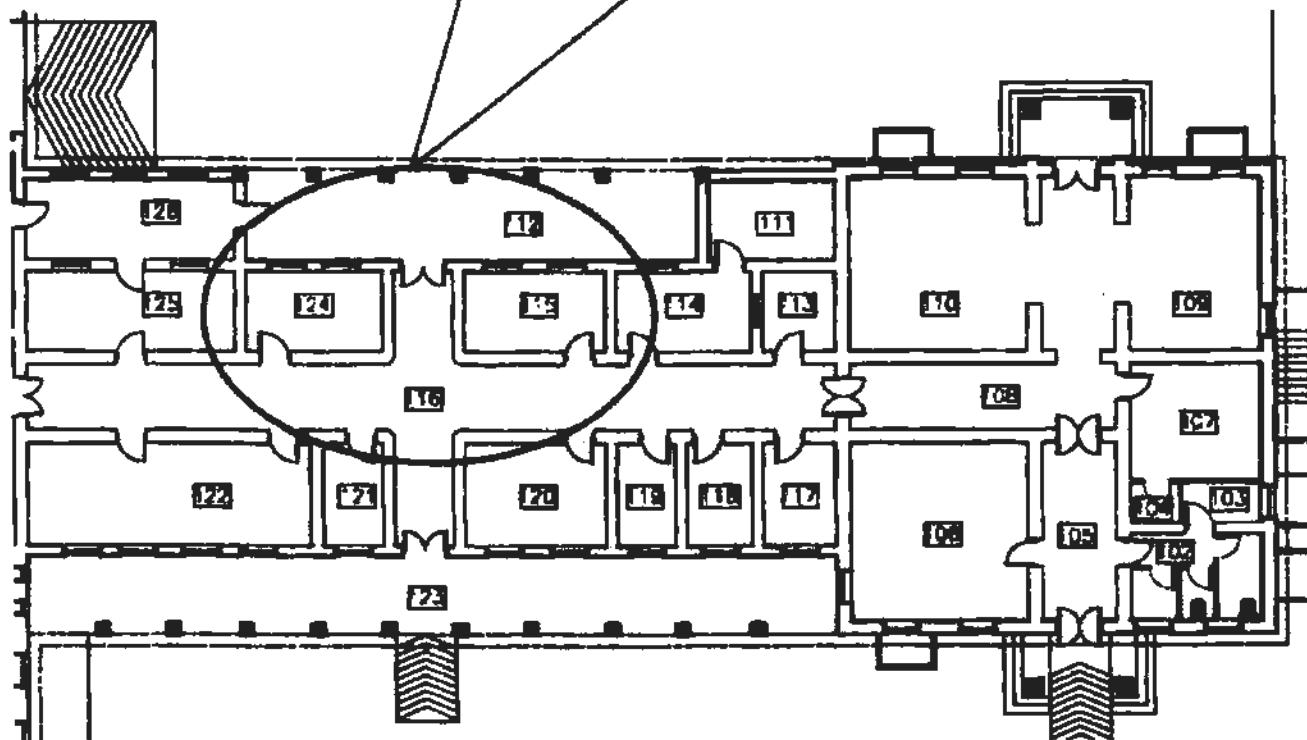
Information: No wall, ceramic tiles floor, roof, ceiling, PVC windows and PVC doors are repairable and operational because all damaged and burned.

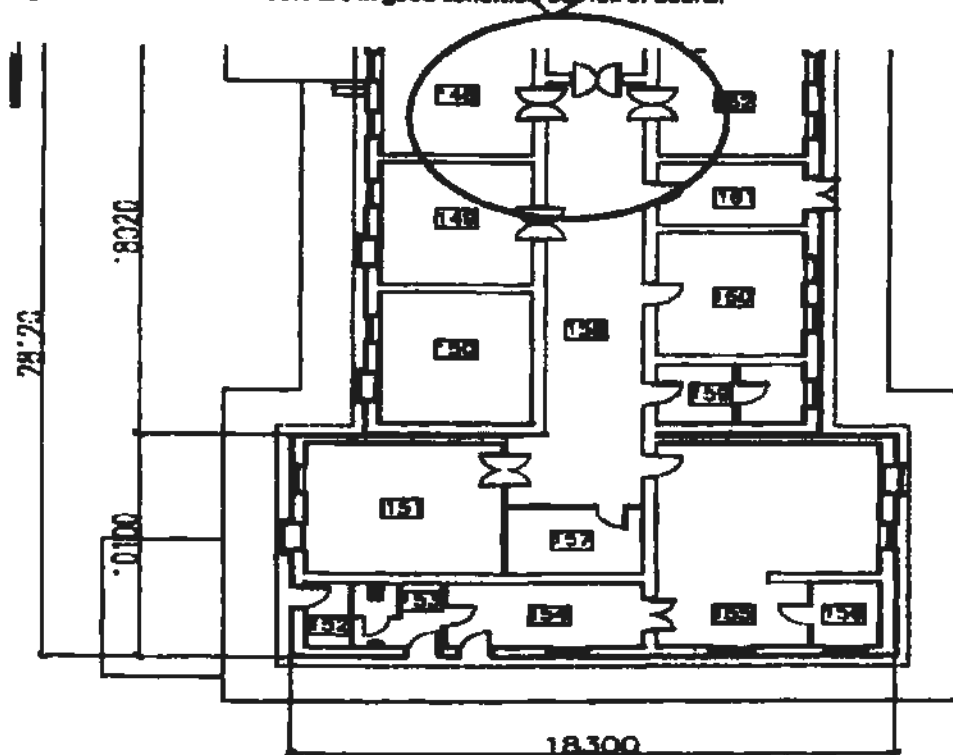
First floor wing B area, south side: The room's concrete wall and roof are damaged. Moreover gypsum suspended ceilings damaged and the ceramic floors are in good condition but full of debris.

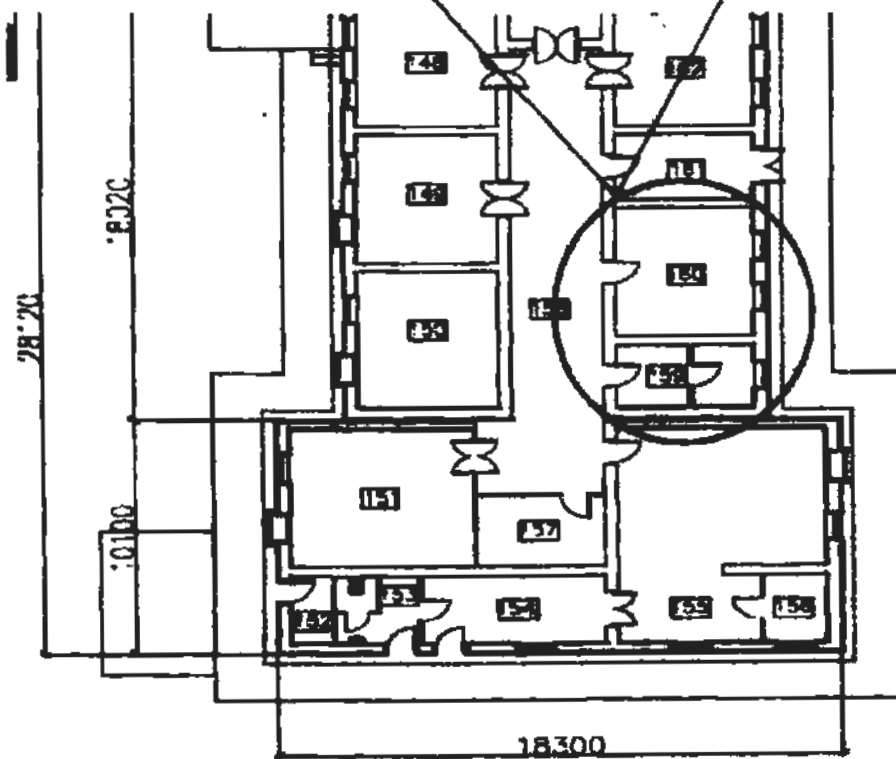
First floor wing B area, south side: the concrete roof and walls damaged by rockets.

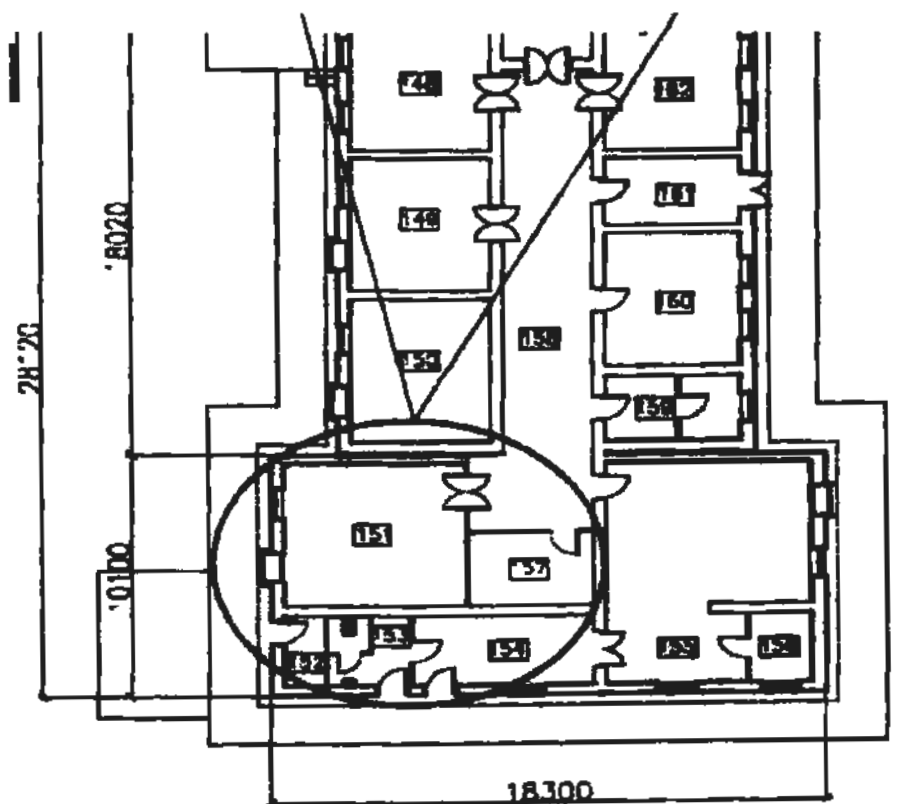
First floor wing B area, south side: Brick masonry walls damaged.

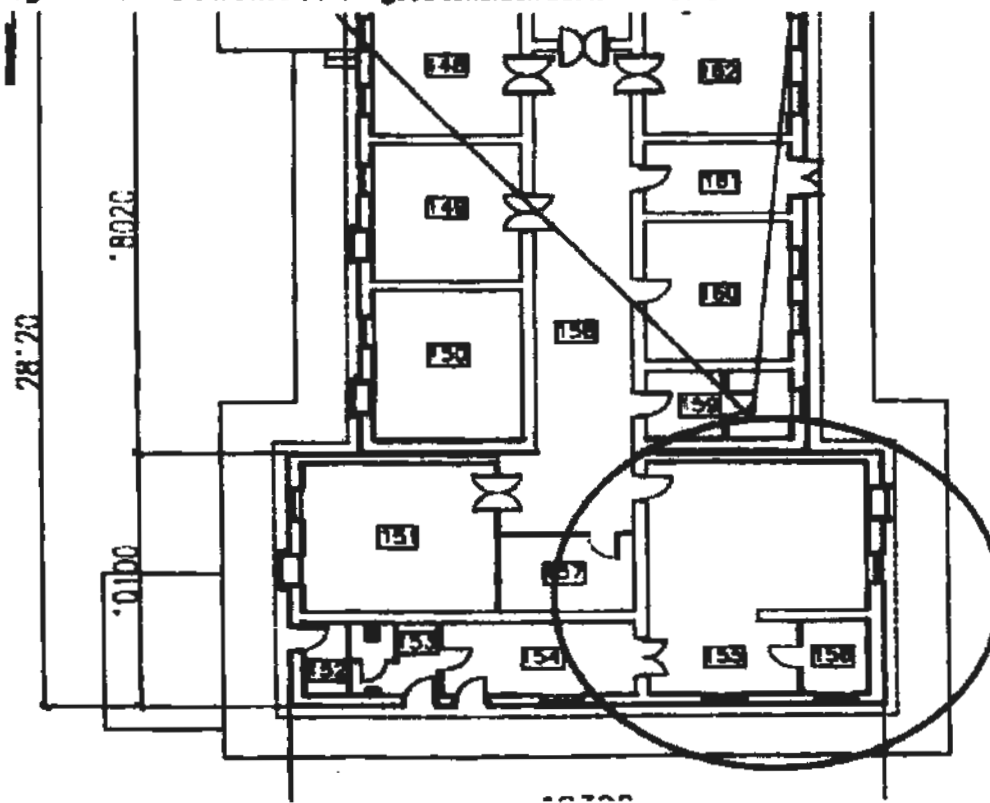
First floor wing B area, south side: The room's concrete wall and roof are damaged. Moreover gypsum suspended ceilings damaged and the ceramic floors are in good condition but full of debris.

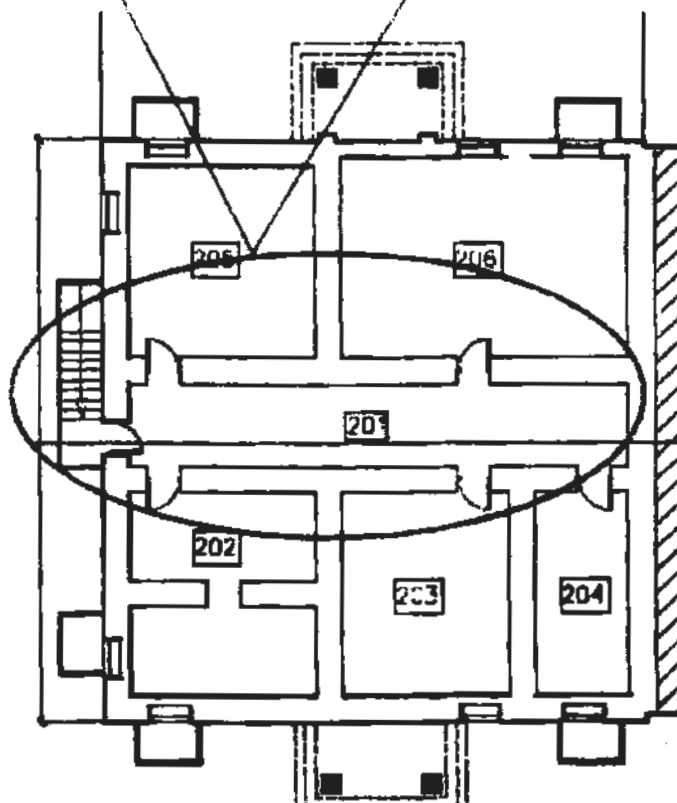
Kunduz MSF Hospital, East Basement: The concrete stair of the east basement is partially damaged.

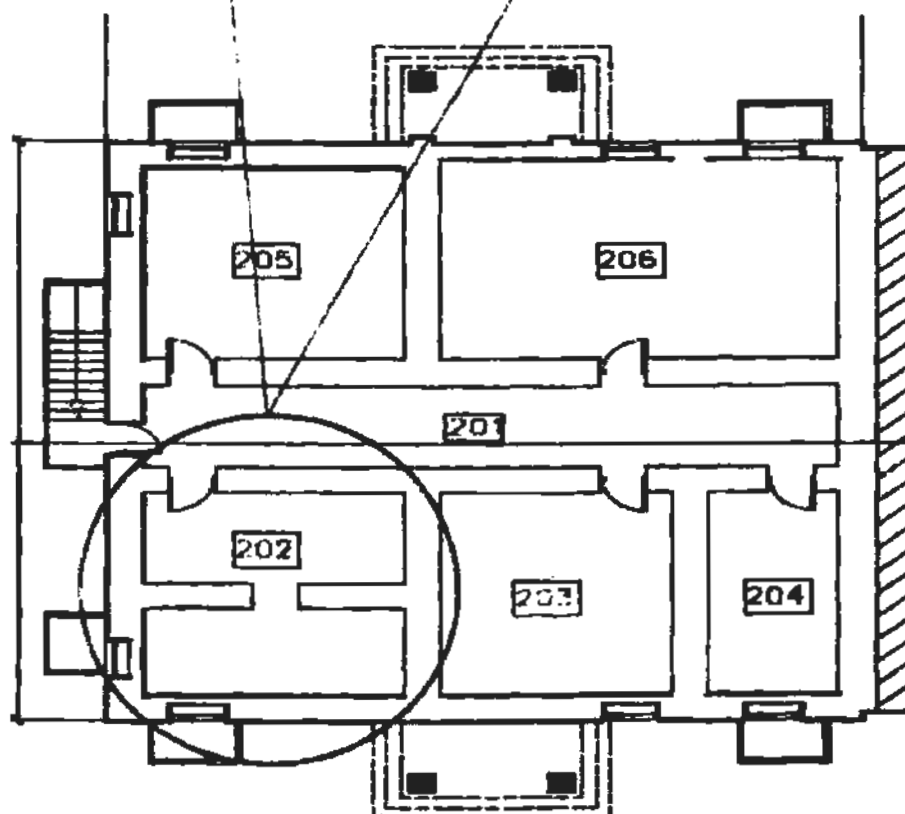
Kunduz MSF Hospital, East Basement: No door was installed in the basement doors and only PVC windows installed without glasses.

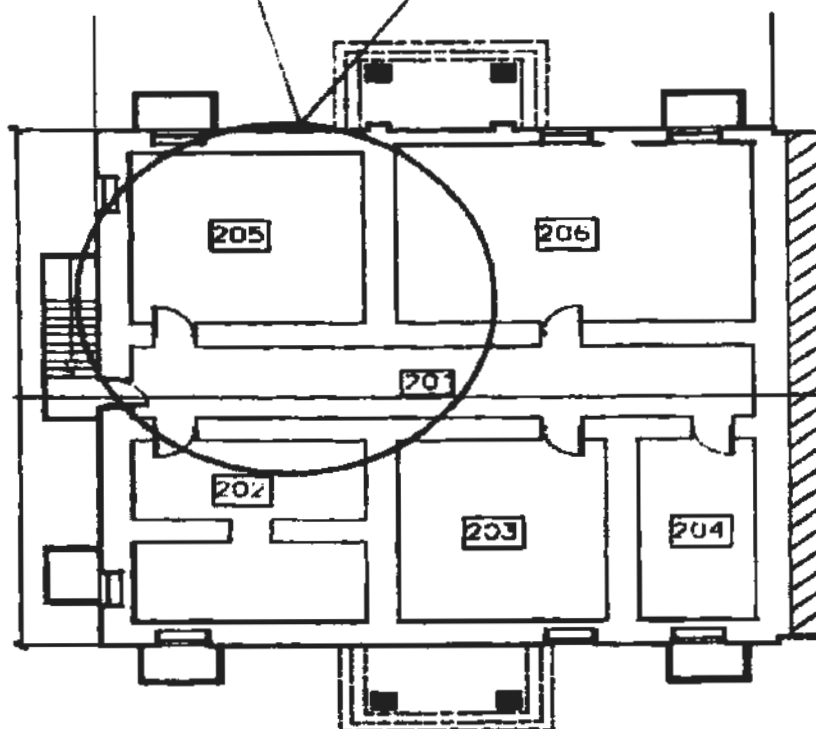
Kunduz MSF Hospital, East Basement: The plaster and paint of the east basement partially damaged and is repairable.

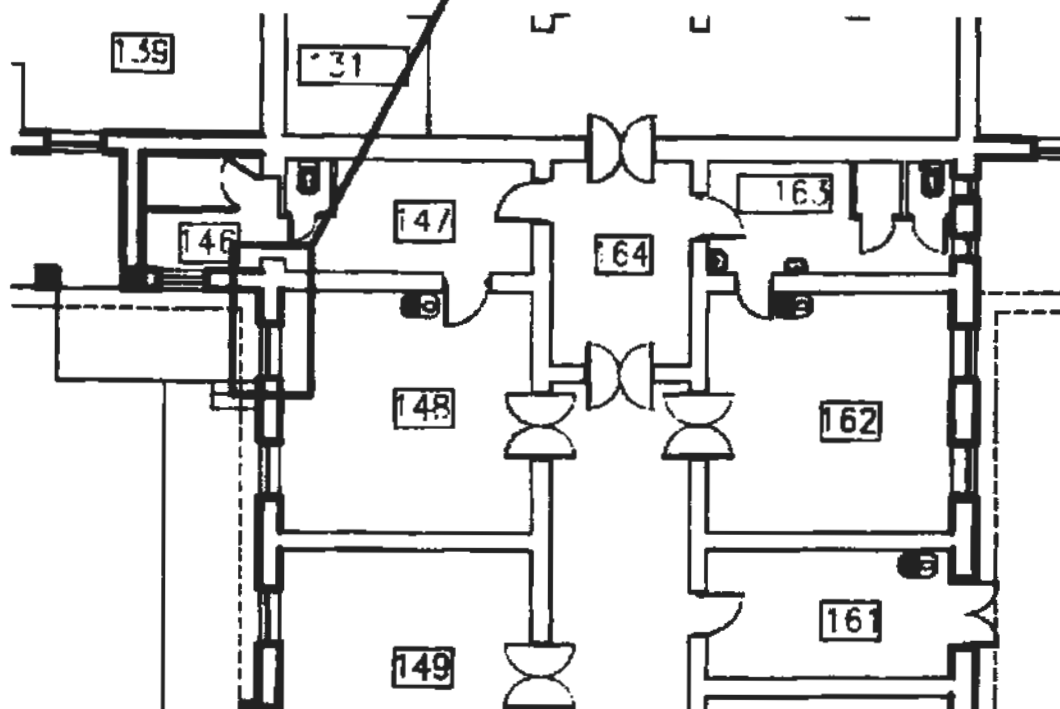
Location: MSF Hospital, Wing B, Room #148
Report: Due to the rocket/ bomb impact the exterior wall has been damaged.

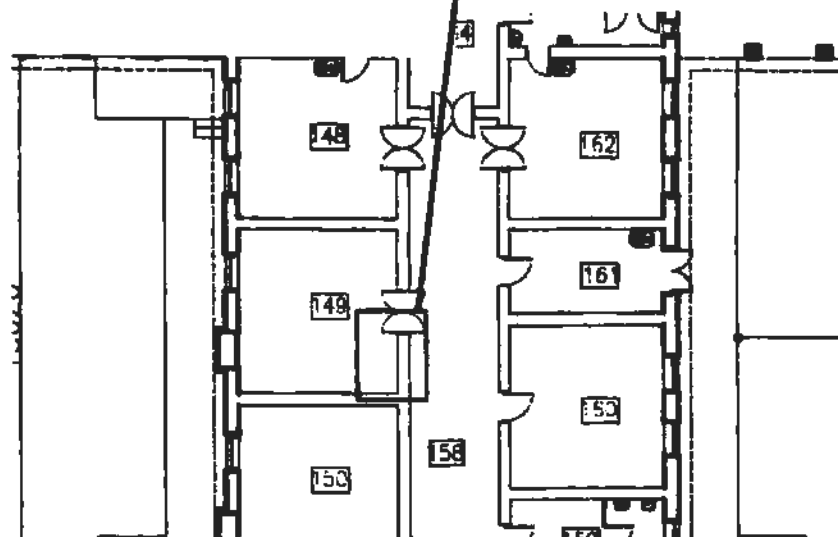
Location: MSF Hospital, Wing B, Room #149
Report: Due to the rocket/ bomb impact the roof slab and interior wall has been damaged.

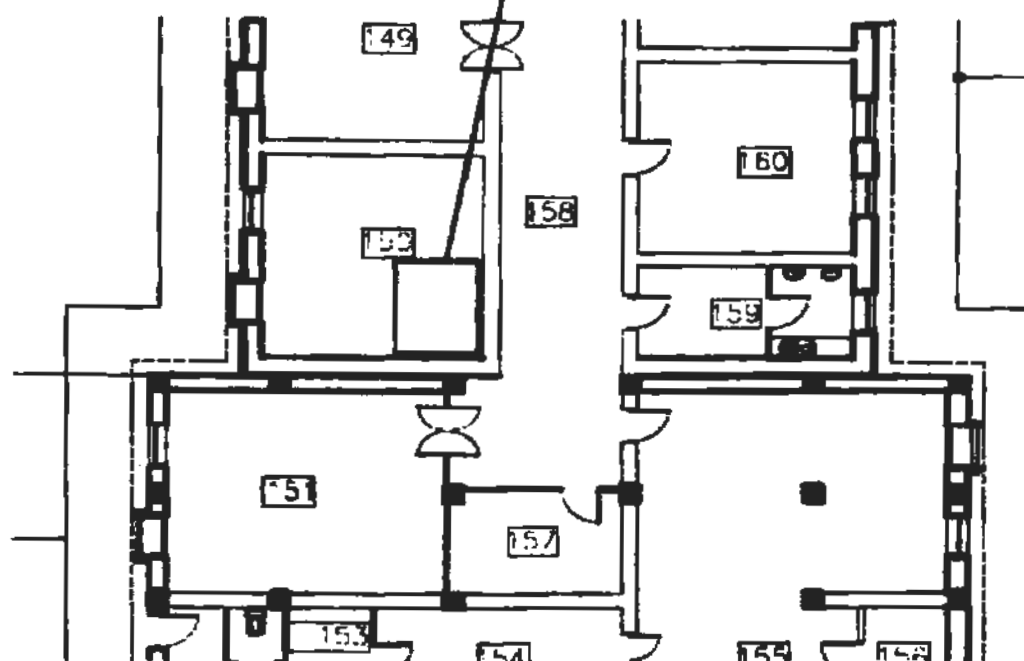
Location: MSF Hospital, Wing B, Room #150
Report: Due to the rocket/ bomb impact the roof slab and floor has been damaged.

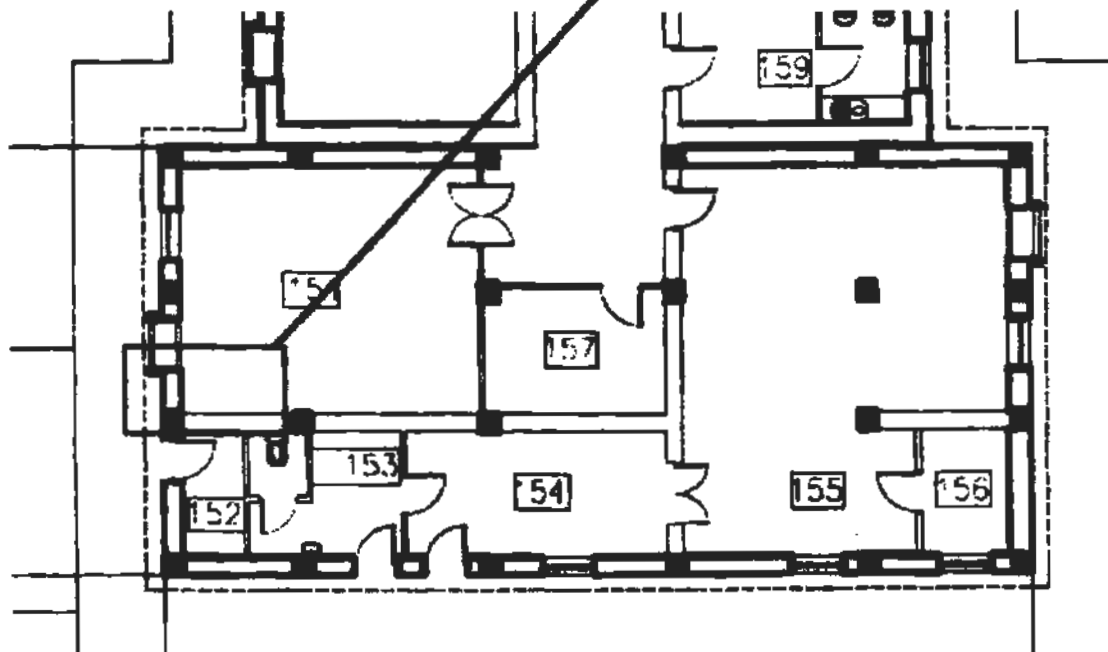
Location: MSF Hospital, Wing B, Room #151

Report: Due to the rocket/ bomb impact the roof slab walls and floor has been damaged.

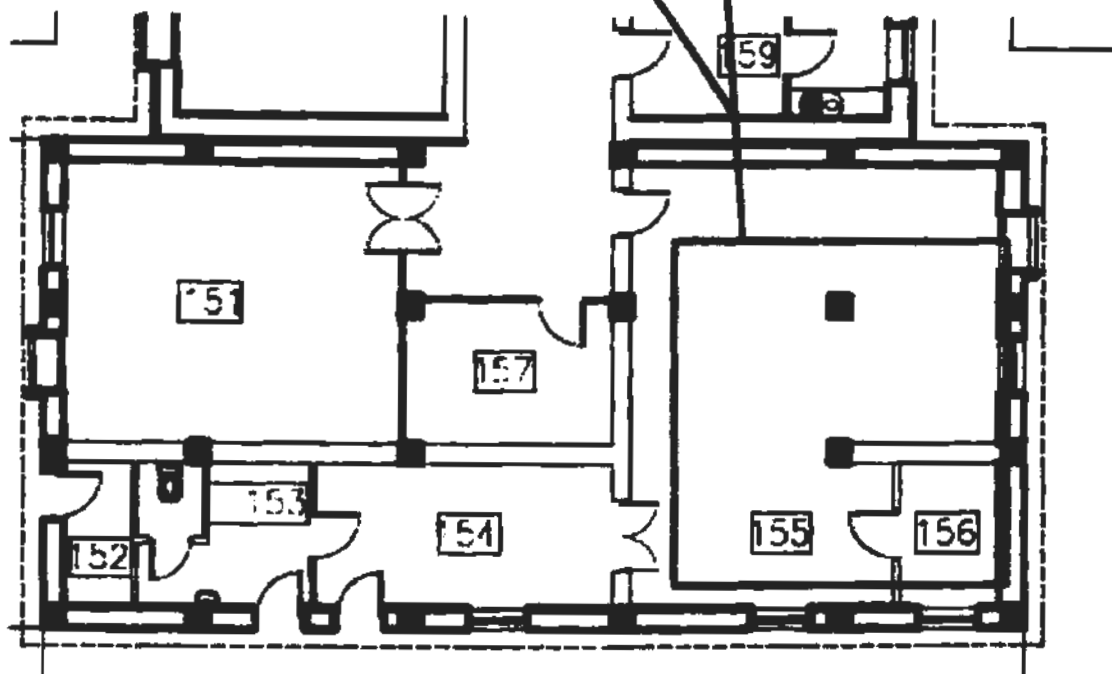
Location: MSF Hospital, Wing B, Room #155

Report: Due to the rocket/ bomb impact the roof slab walls and floor has been damaged.

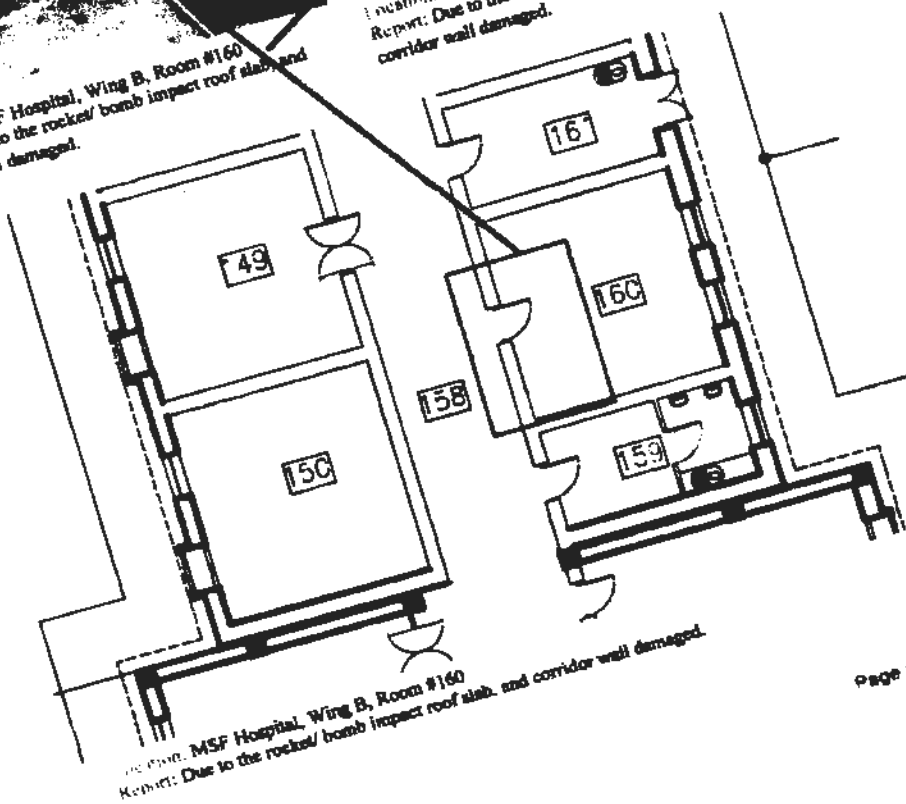
Photo #50
Location: MSF Hospital, Wing B, Room #160
Report: Due to the rocket/ bomb impact roof slab, and corridor wall damaged.

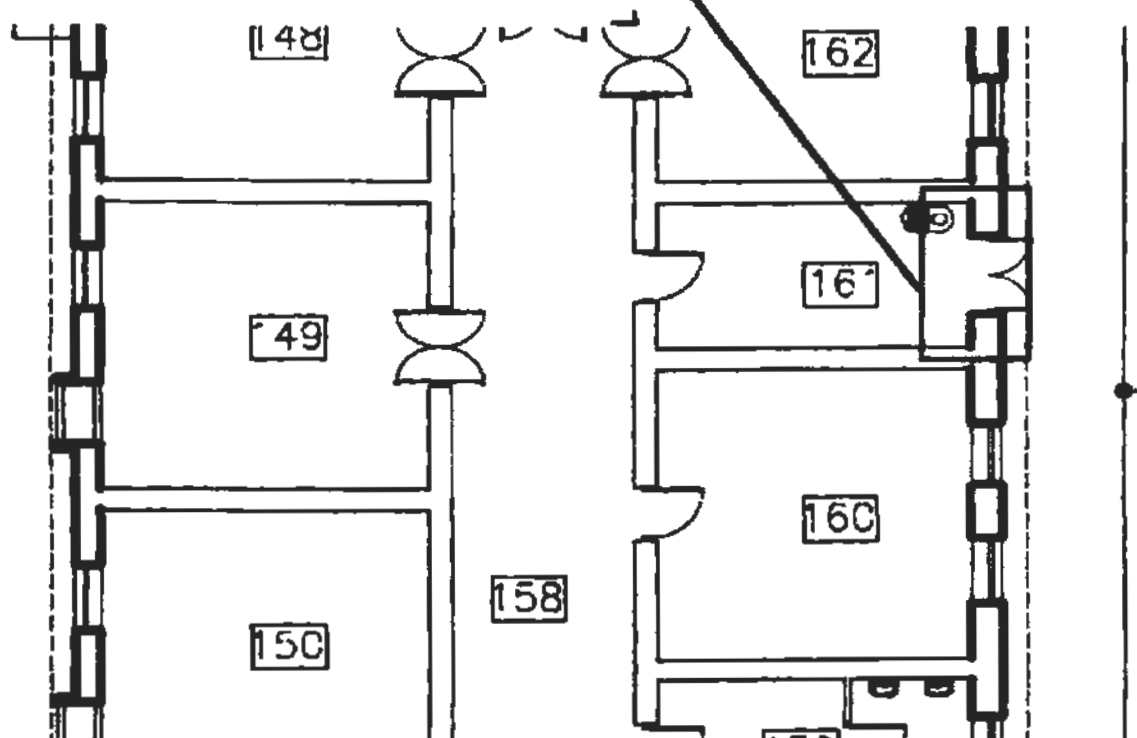
Location: MSF Hospital, Wing B, Room #161
Report: Due to the rocket/ bomb impact exterior wall with the door lintel has been damaged.

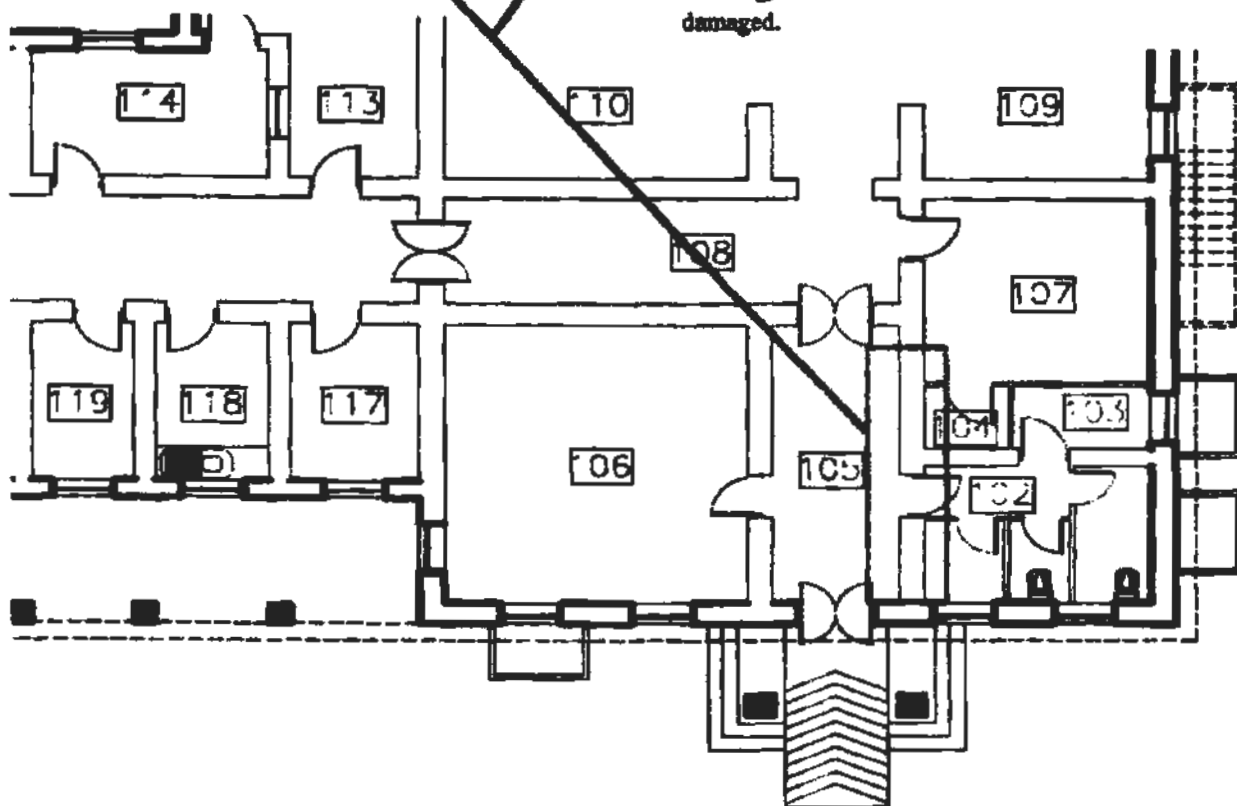
Location: MSF Hospital, Wing A, Room #105
Report: Due to the rocket/ bomb impact the entire wing/section has been damaged, all roof trusses, roof sheeting, wall with the doors and windows has been damaged.

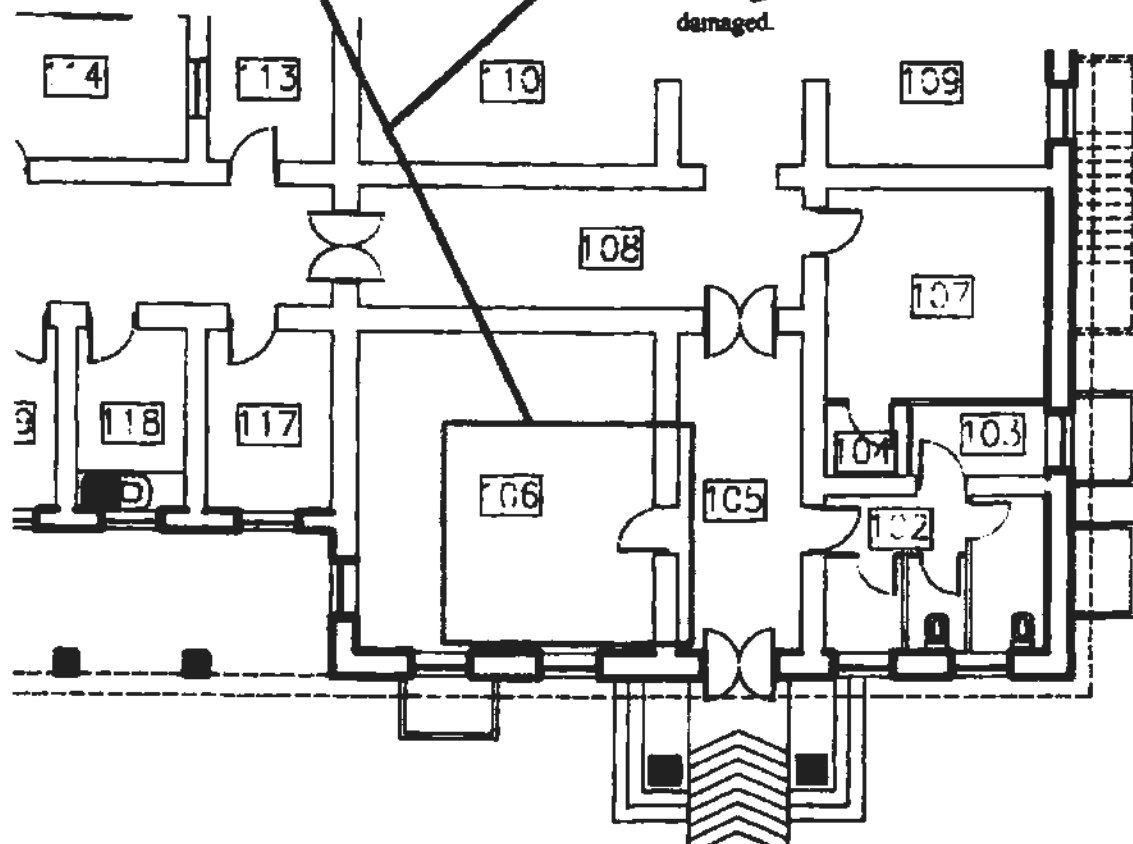
Location: MSF Hospital, Wing A, Room #106
Report: Due to the rocket/ bomb impact the entire wing/section has been damaged, all roof trusses, roof sheeting, wall with the doors and windows has been damaged.

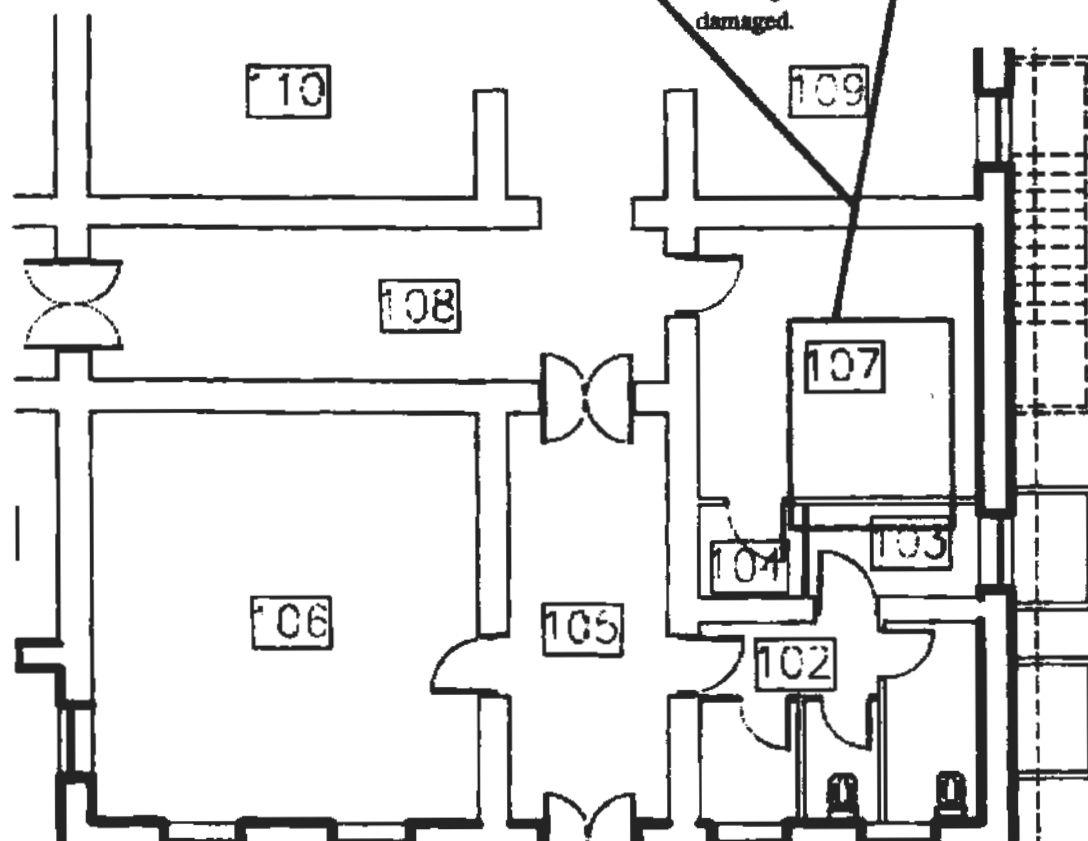
Report: Due to the rocket/ bomb impact the entire wing/section has been damaged, all roof trusses, roof sheeting, wall with the doors and windows has been damaged.

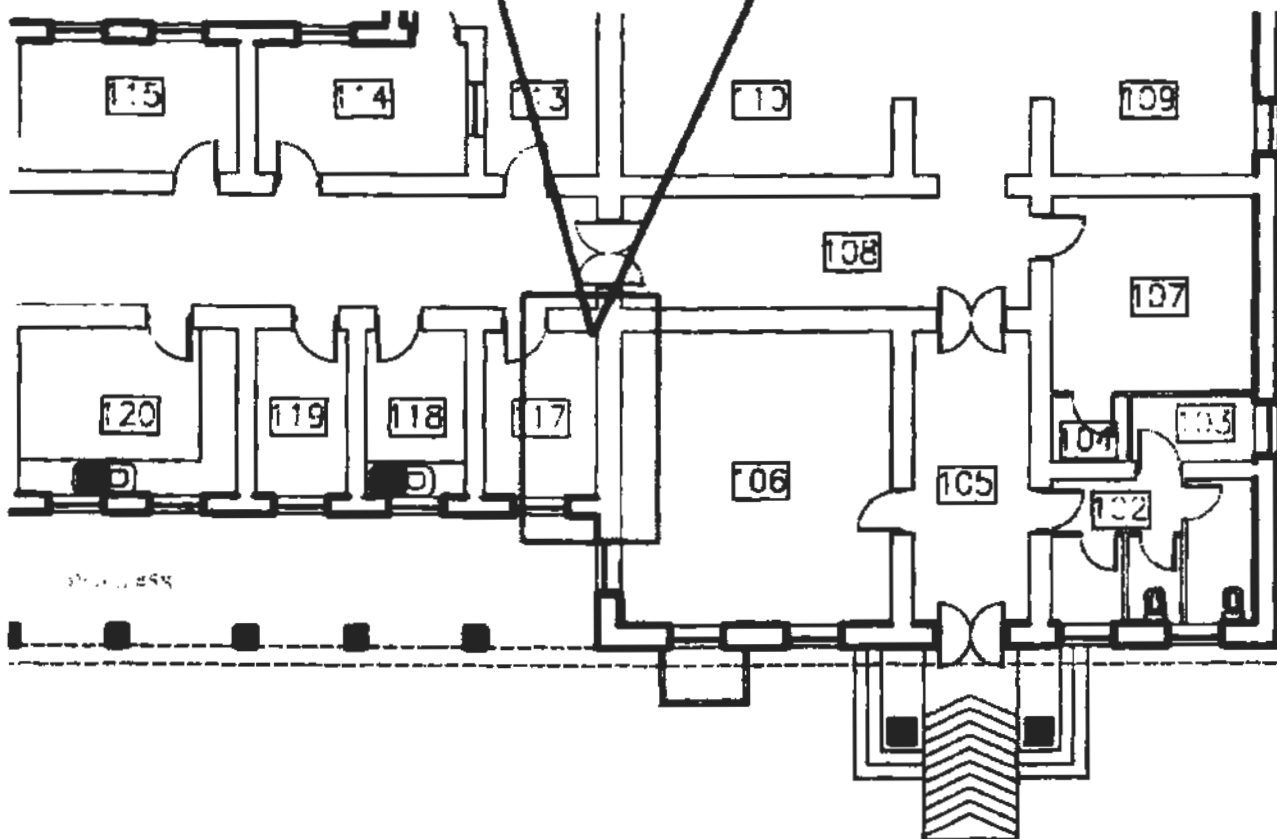
Location: MSF Hospital, Wing B, Room #117
Report: Due to the rocket/ bomb impact interior wall with the door lintel has been damaged.

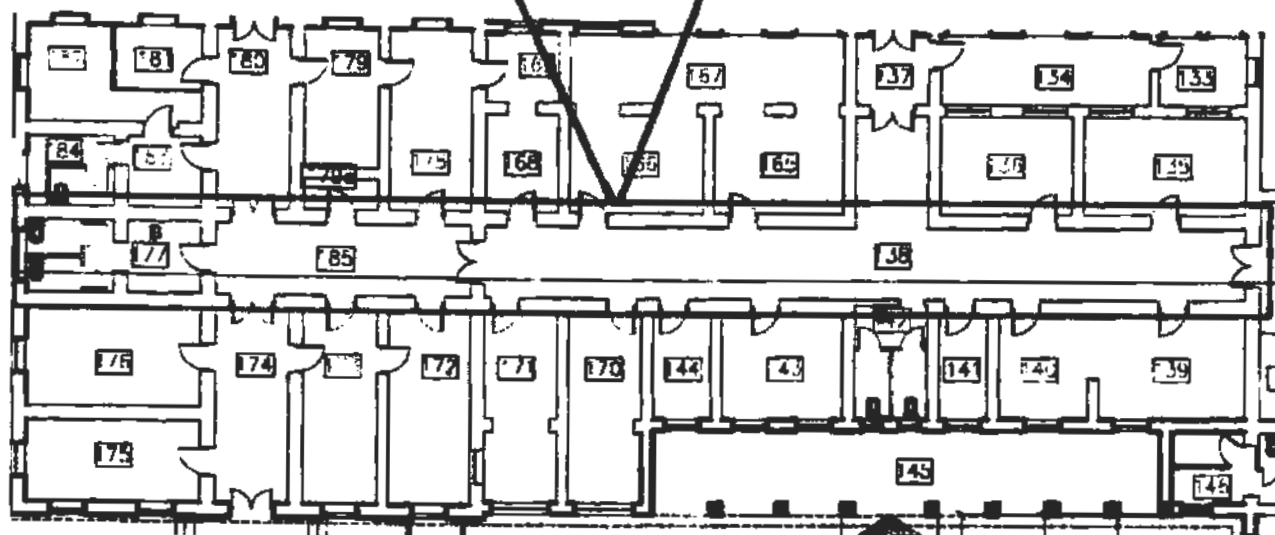
Location: MSF Hospital, Wing C, Room #138

Report: Due to the fire and rocket/ bomb impact the roof truss with sheets has been damaged. The entire section C physically damaged. Roof truss including the sheeting, doors, windows, existing equipment and stuff has been damaged and burned. Nothing is reparable. The most damages occurred on this section.

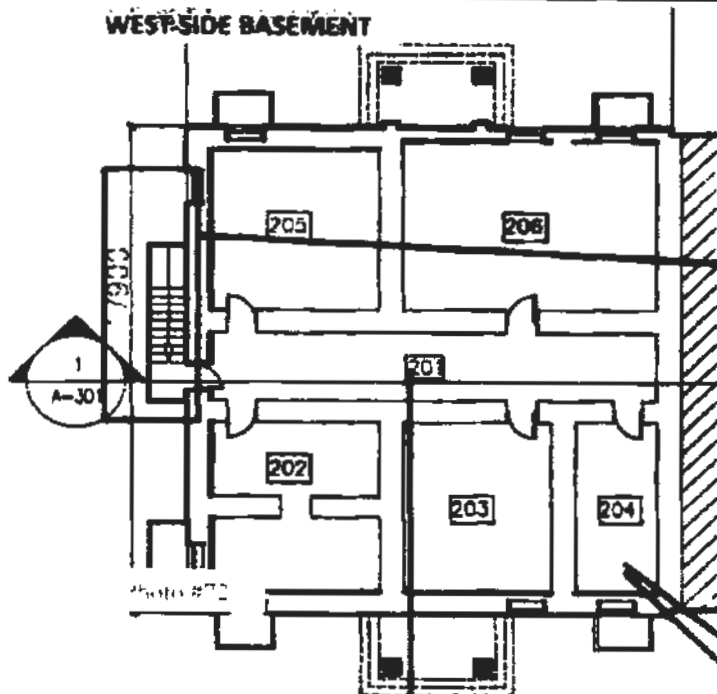
Photo #73

Location: MSF Hospital, West side Basement
Report: Due to the rocket/ bomb impact the stair of this basement has been damaged. This basement has been constructed by brick masonry .

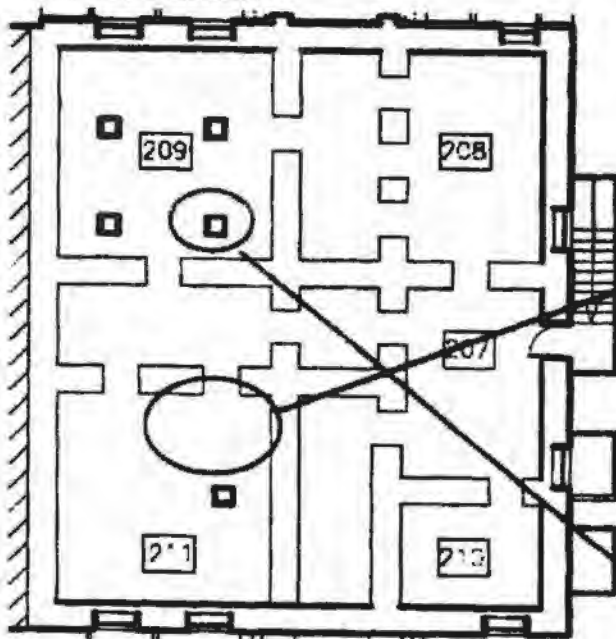
Photo #76

Location: MSF Hospital, East side Basemen
Report: Due to the rocket/ bomb impact the roof slab of the basement has been damaged. This basement has concrete frame structure.
