SUBJECT: Search and Recovery Report 9/CIL/96, Crash Site Associated with REFNO 2003, Tang Island, Kampong Saom Province, Kingdom of Cambodia, 28 October to 12 November 1995

SUBJECT: Search and Recovery Report 9/CIL/96, the Crash Site Associated with REFNO 2003, Tang Island, Kampong Saom Province, Kingdom of Cambodia, 28 October to 12 November 1995

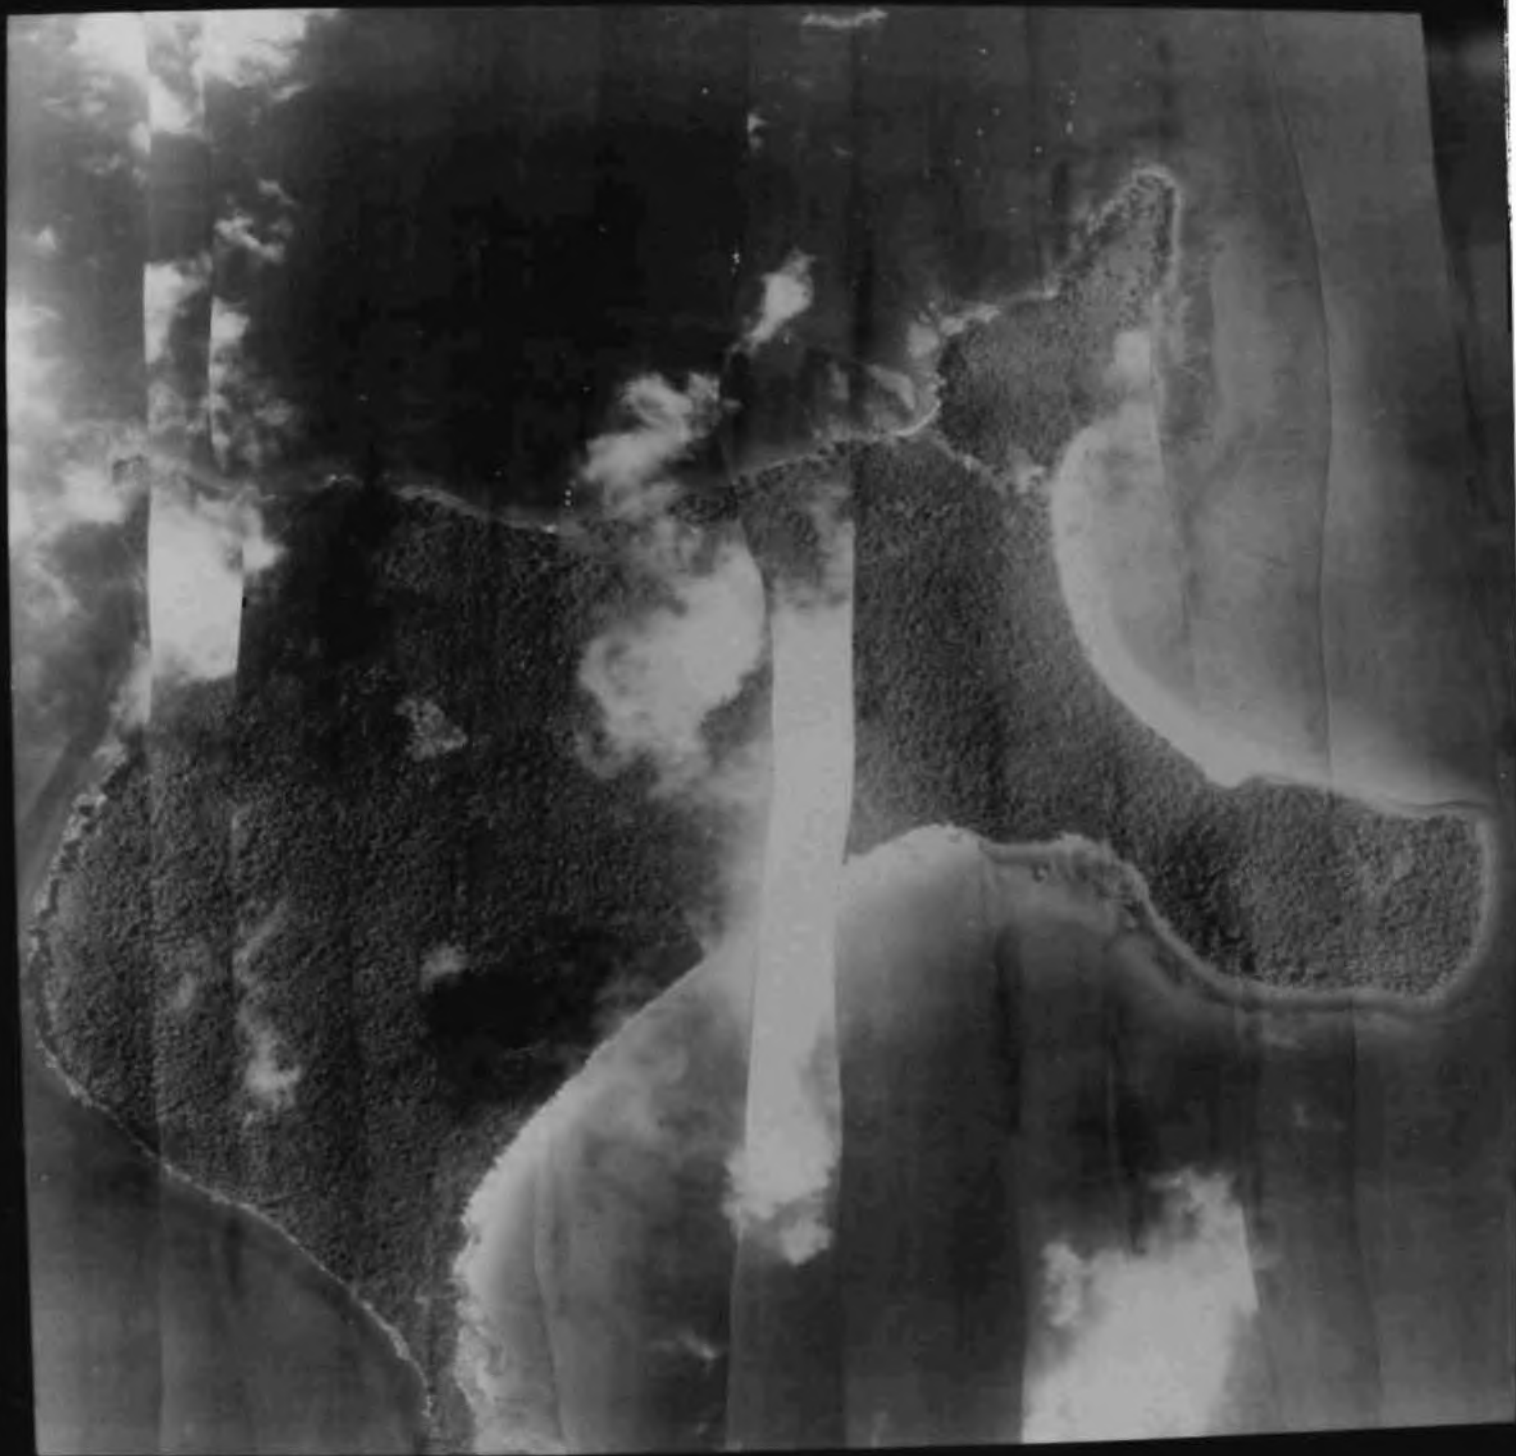
1. Aerial reconnaissance photograph prior to the incident. View showing northern portion of Tang Island.
2. Closeup aerial reconnaissance photograph of the eastern beach depicting wreckage of Knife 31 and Knife 23.

NORTHERN END OF KOU TANG
16 MAY

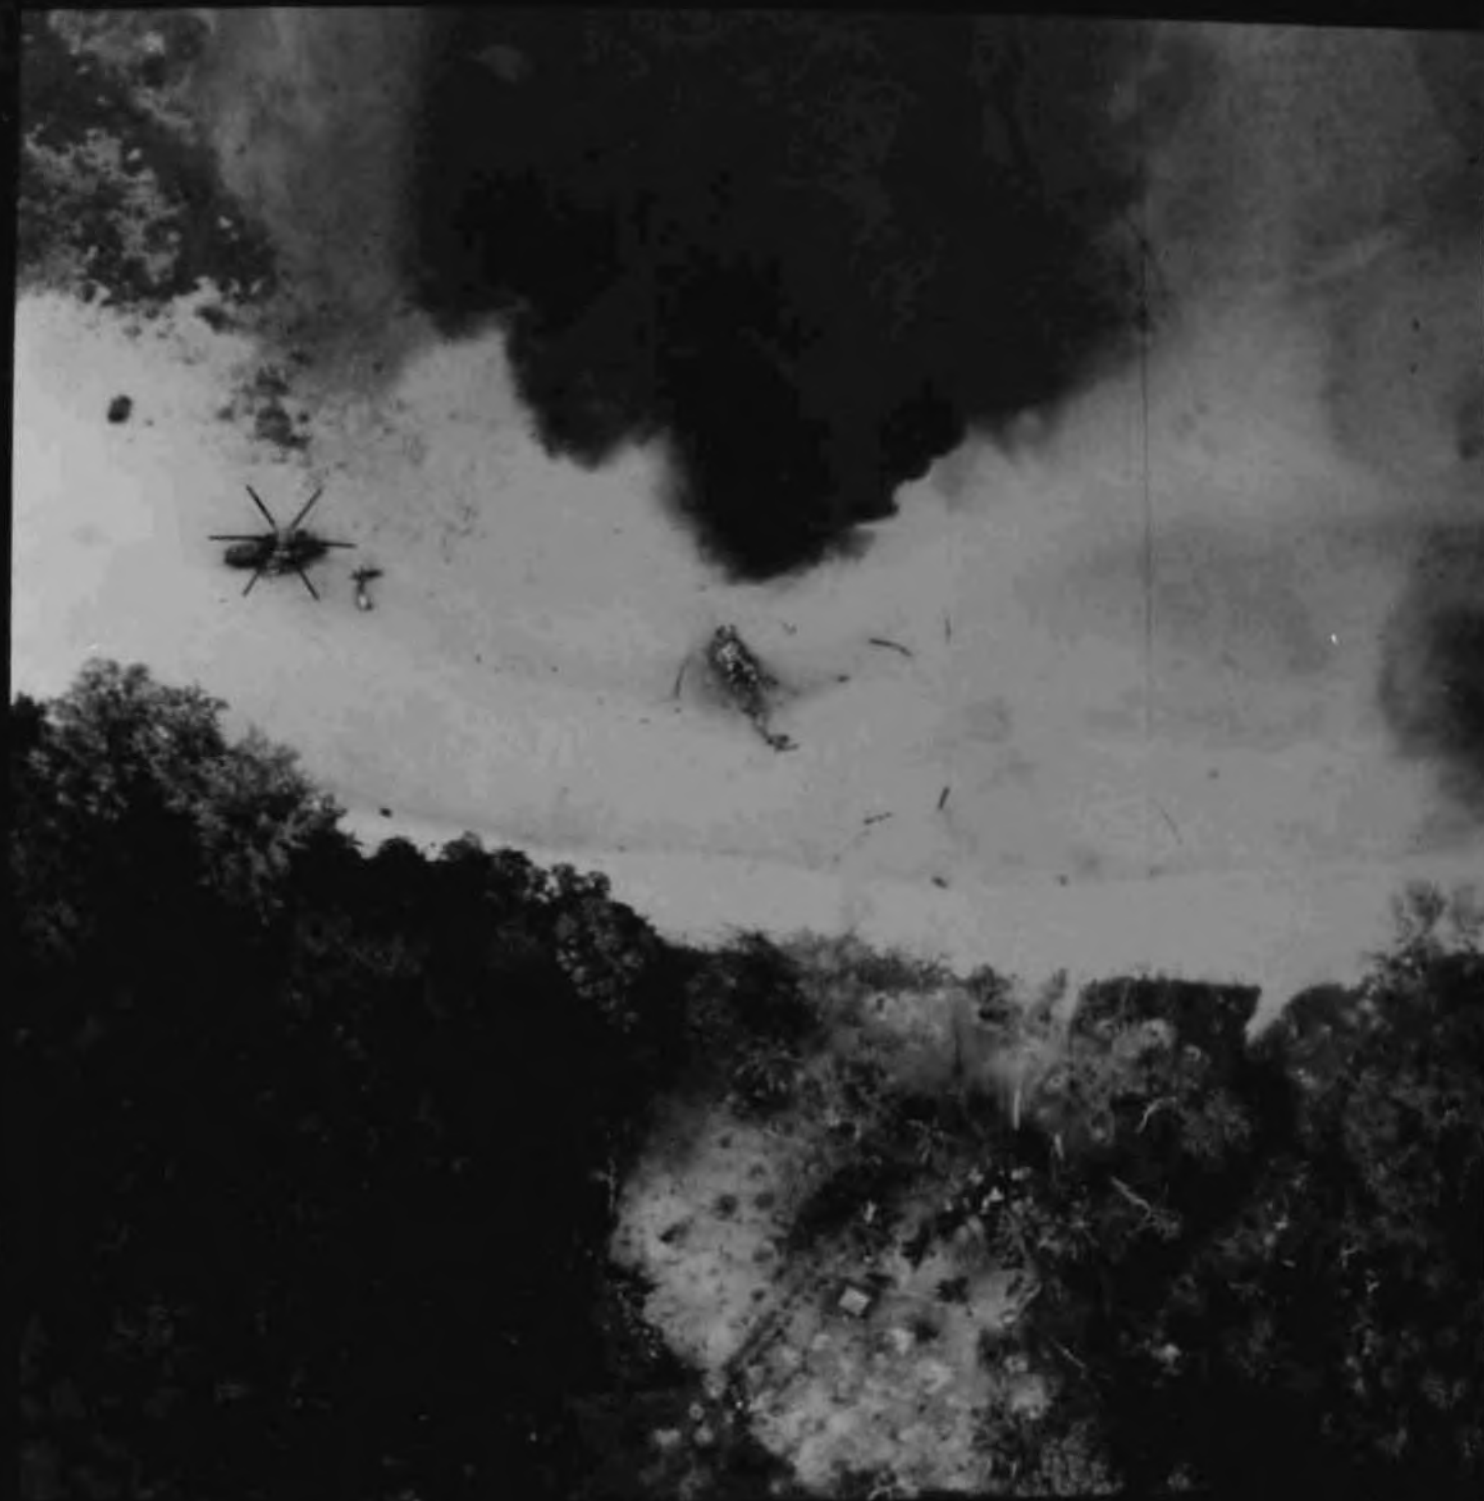
Encampment at eastern beach, around
noontime 15 May (after strikes by
A-7s, F-4s, and an AC-130.)

- c. Recovered wreckage is consistent with post event photography which depicts charred wreckage (see Enclosure 6 Photograph 2).
- d. The concentration of human remains were found adjacent, under and inside the wreckage of Knife 31.
