Joint High Speed Vessel (JHSV)

Follow-on Operational Test and Evaluation (FOT&E) Report

September 2015

This report on the Joint High Speed Vessel (JHSV) assesses the adequacy of testing, the operational effectiveness, and operational suitability of the JHSV.

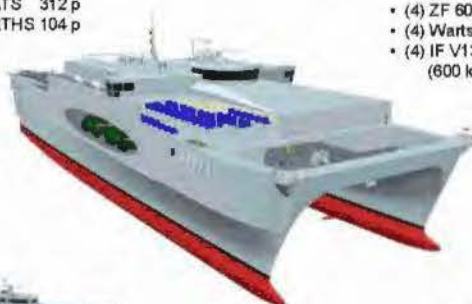
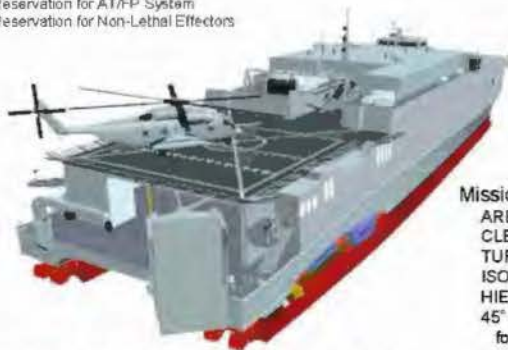
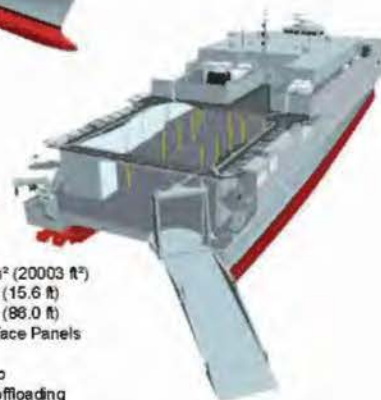
- (4) 50 Caliber Machine Guns
- Reservation for AT/FP System
- Reservation for Non-Lethal Effectors

Mission Bay

AREA (with Tie Downs) 1858 m² (20003 ft²)
 CLEAR HEIGHT 4.75 m (15.6 ft)
 TURNING DIAMETER 26.2 m (86.0 ft)
 ISO TEU STATIONS 6 Interface Panels
 HIEX Foam Firefighting System
 45° slewing articulated quarter ramp for rapid and efficient loading and offloading

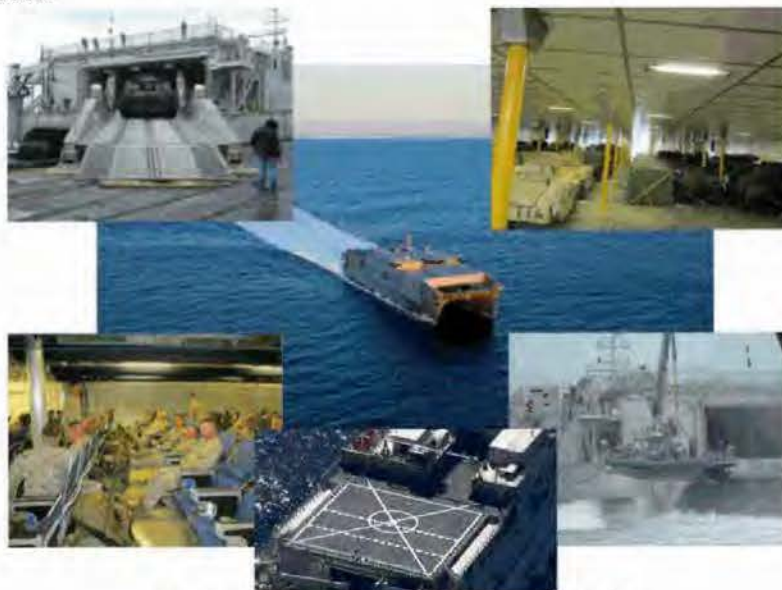
Figure 2. Joint High Speed Vessel (JHSV)

JHSV is a high-speed, shallow-draft surface vessel designed for intra-theater transport of personnel and medium payloads for the Joint Force, as shown in Figure 2. It is a redesign of a commercial catamaran capable of accessing relatively austere ports. JHSV can support an embarked force of 104 personnel for up to 14 days or a larger force of 312 personnel for 4 days. JHSV has a large mission bay accessible from piers or floating causeways via an integrated, stern-mounted ramp. The ramp and mission bay can accommodate both wheeled and tracked vehicles up to and including a combat-loaded M1A2 battle tank. The mission bay also can host 20-foot equivalent containers, including those that require power and data connections. JHSV has a flight deck that can support landing, fueling, and power requirements for various unarmed Navy helicopters up to and including the MH-53E. JHSV is also equipped with a stern-mounted crane used in this testing to launch the SDV, but is also capable of launching boats such as an 11-meter Rigid Hull Inflatable Boat through Sea State 2.

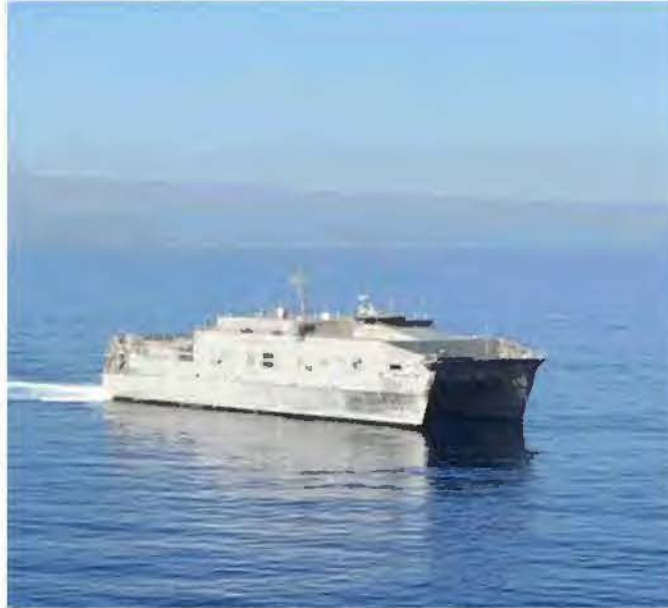
Figure 3. USNS *Millinocket* (JHSV-3) in Sea State 3 Conditions near Camp Pendleton

Figure 3 shows USNS *Millinocket* the day of the second test in Sea State 3 conditions. The seas in Figure 2 look very calm, but data from the nearby National Oceanic and Atmospheric Administration buoy indicated a swell from the south with significant wave height of 2½ feet (0.7 meters) and a 12½-second period, which technically meets the North Atlantic Treaty Organization Sea State definition for Sea State 3.

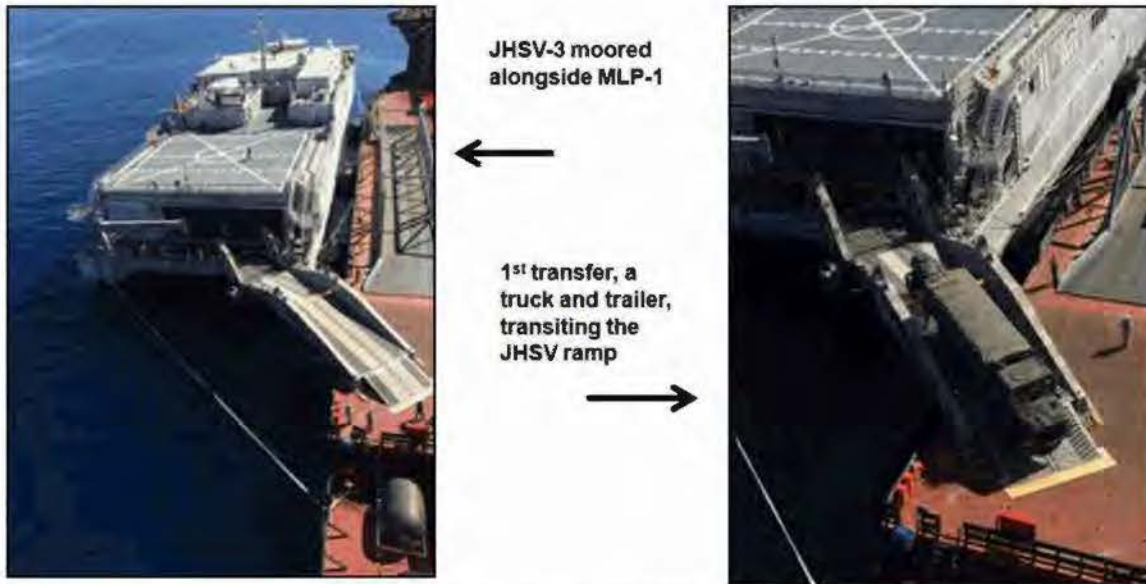
Figure 4. JHSV alongside MLP (CCS)

Although the seas in the lee of MLP (CCS) (an area sheltered from the wind and waves), where JHSV was moored, were estimated to be Sea State 1 to 2, the vehicle transfer test failed. Figure 4 shows the two ships moored skin-to-skin with the JHSV ramp deployed. The hydraulic ram used to swing the ramp port to starboard tore free from its anchor point on the JHSV transom. The small amount of movement between the ships, even in calm Sea State 1 to 2 conditions, was enough to cause the damage when a truck pinned the foot of the ramp onto the raised vehicle deck of MLP (CCS) as it transited the ramp. The physical strength of the ramp was not compromised; the Marine Corps truck returned to JHSV, but this ended the vehicle transfer portion of the test. The Navy has not made any design changes to the JHSV ramp to enable these transfers. JHSV is not effective for operations with MLP (CCS) unless in Sea State 1 conditions, which is an unacceptable constraint for operational deployment.

In order for the Navy to conduct open ocean equipment transfers between JHSV and MLP (CCS), DOT&E recommends that the Navy modify the JHSV ramp to increase its sea state rating, or develop a new, higher sea state rated ramp, then retest at-sea equipment transfers with MLP (CCS).

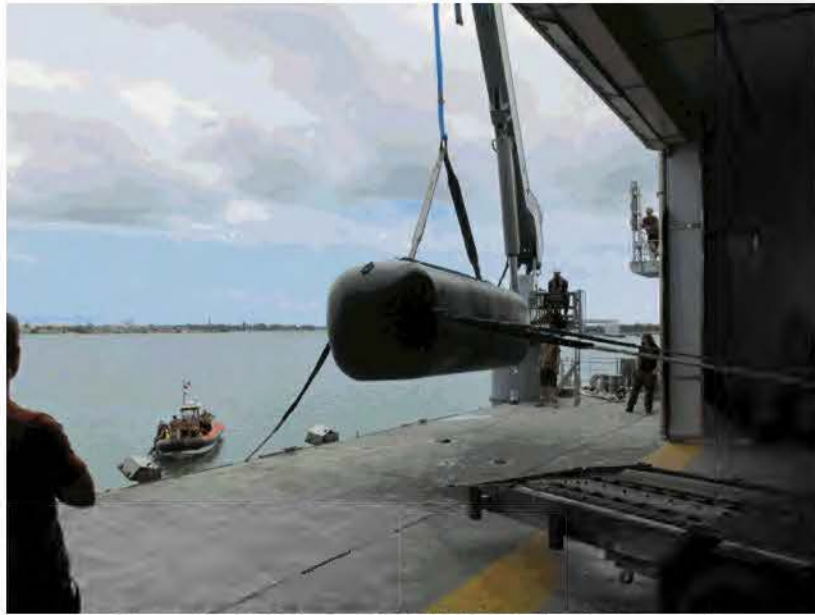
Figure 5. SDV Suspended While Trailer is Removed

The launch of the SDV is deceptively simple. Figures 5 and 6 show the SDV after it was lifted from the trailer during a pier-side test, and just before it was placed in the water during an underway test.

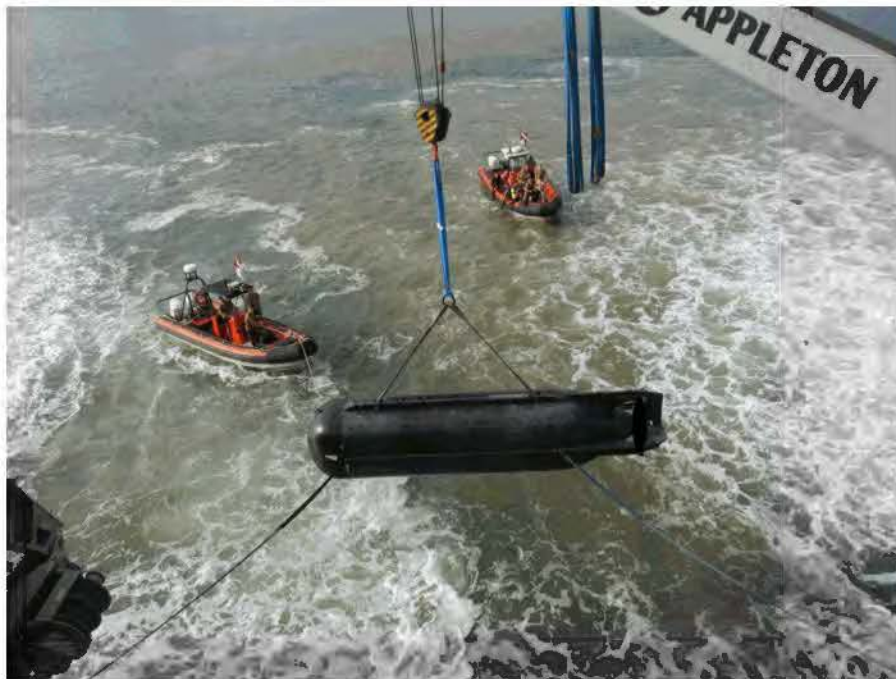
Figure 6. SDV Being Placed in the Water

Figure 6 illustrates several points of interest in the SDV launch. Two tending lines, one attached at the front and the other at the back of the SDV, extend to personnel on JHSV. A third line attached at the front of the SDV is secured to a support boat. The second boat shown in the figure has Navy Special forces swimmers and divers. Turbulent water, from the JHSV waterjets, is also clearly shown in the Figure 6. Prior to swimmers and divers entering the water, the JHSV crew declutches the engines from the waterjets (they put the ship in neutral). This clears the

turbulence and protects the in-water personnel from an unlikely, but possible, ingestion by the waterjet suction. Divers equipped with scuba gear ready the SDV for use while the swimmers detach the lines. The swimmers first detach the two tending lines from the ship, and then detach the two crane suspension lines. The hoat, with the last attached line, gently pulls the vehicle, directing it away from JHSV. By this time, the divers are entering the operating stations of the SDV and the swimmers detach the last line as the operators settle into position. As the swimmers exit the water, back to the support boat, and the divers drive the SDV away from JHSV, the engines can be clutched back in returning JHSV to powered operation; this all happens very quickly. As shown previously in Table 2, the swimmers are in the JHSV waterjet risk area during launch for only 1 to 2 minutes.

Two other items of concern uncovered by this test are the vulnerability of the SDV to a pendulum swing motion while suspended by the crane, and the possible effects on SDV operators and passengers from JHSV engine exhaust. While suspended, the SDV was vulnerable to pendulum motions during both the open-ocean launch and recovery of the SDV events, and the tending line personnel were challenged to control this. As noted, the significant wave height indicated Sea State 3 conditions during the open-ocean portion of the test. As shown previously in Table 2, the open-ocean launch time, from lifting the SDV from the trailer, launching it, and then clutching in the JHSV engines, took 3 minutes. As shown previously in Table 3, the recovery from declutching engines to placement of the SDV in the trailer cradle took 16 minutes. The extended recovery time was due to the challenges the line tenders experienced controlling the pendulum motions of the SDV. A mitigating factor for actual missions may be, by default, a Sea State 2 limitation. The support boats for this test operated from shore, but in actual operations, the boats would be launched by JHSV prior to launching of the SDV. JHSV's IOT&E demonstrated that launch or recovery of these type boats was limited to Sea State 2. At Sea State 2, the pendulum motions of the SDV should be less. Alternatively, the crane could be upgraded with a pendulation control system.

- Investigate the availability of a pendulation control system for the JHSV stern-mounted crane.
- Evaluate the effect of JHSV exhaust gases on SOF personnel readying for oxygen transits.
- Evaluate JHSV capabilities to support personnel and equipment for various SOF mission packages.

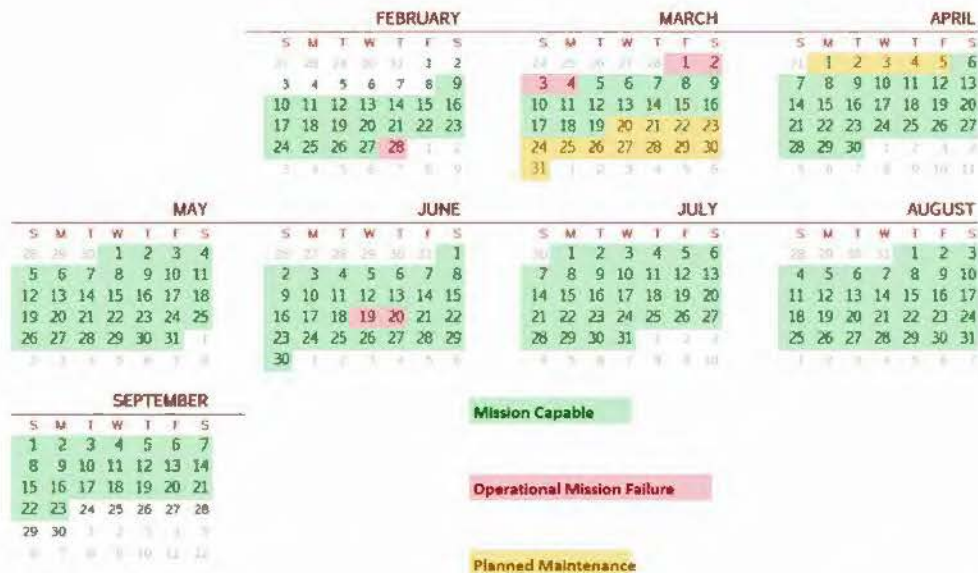
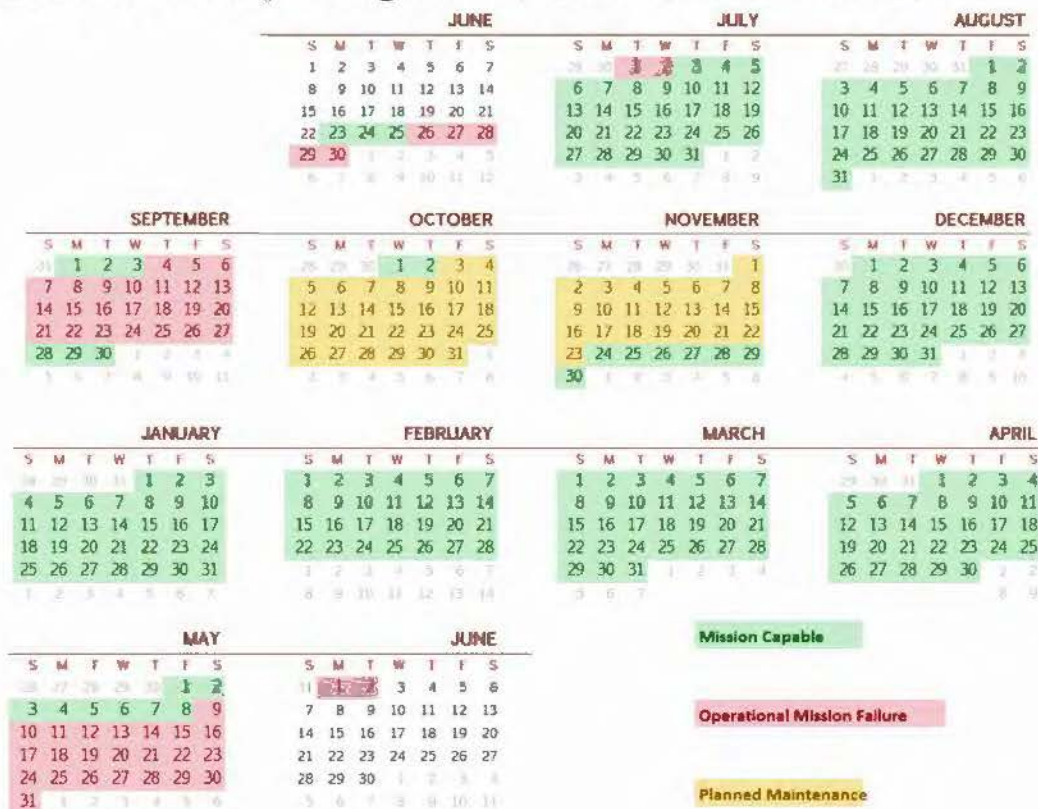
Figure 7. USNS *Spearhead* Availability during Test Periods

Although JHSV remains operationally suitable, the demonstrated availability has decreased from 98 percent (reported in the IOT&E report), to 87 percent (calculated using both IOT&E and FOT&E data), Figure 7. Ship availability calculations do not include planned maintenance periods. There are no availability requirements for this ship class but there are availability targets. The ship’s availability target is 81 percent. Assuming a 15-day mean logistics delay time for parts not held onboard, the targeted (predicted) availability is 81 percent. Using the combined IOT&E and FOT&E data, the 80 percent lower confidence bound for availability is 81 percent.⁴ The main drivers of ship unavailability were the Ship Service Diesel Generators (SSDGs), waterjets, and Ride Control System (RCS).

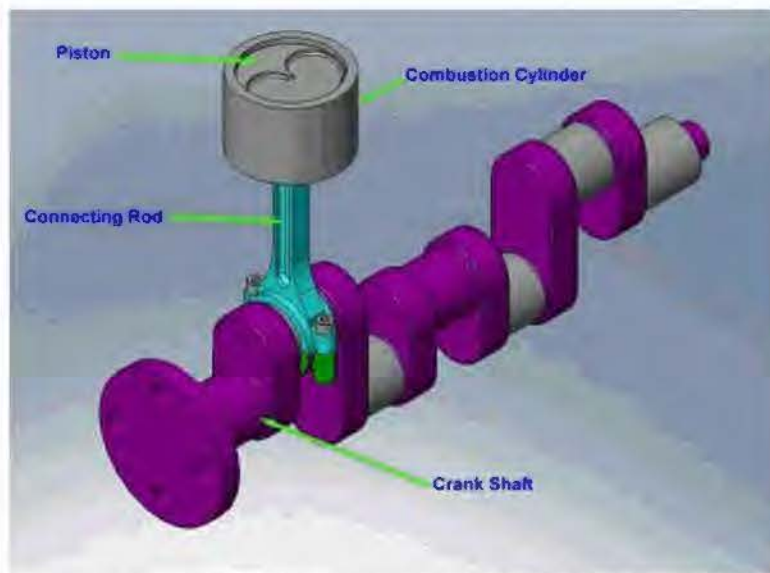
Figure 8. Piston, Connecting Rod, Crank Shaft

Connecting rods that connect the reciprocating pistons to the crank shaft (Figure 8) have failed in SSDGs installed in the JHSV ship class. Currently, all new and rebuilt Fincantieri-manufactured SSDGs are being fitted with a third-generation connecting rod, including a rebuilt of # 4 SSDG on USNS *Spearhead*.

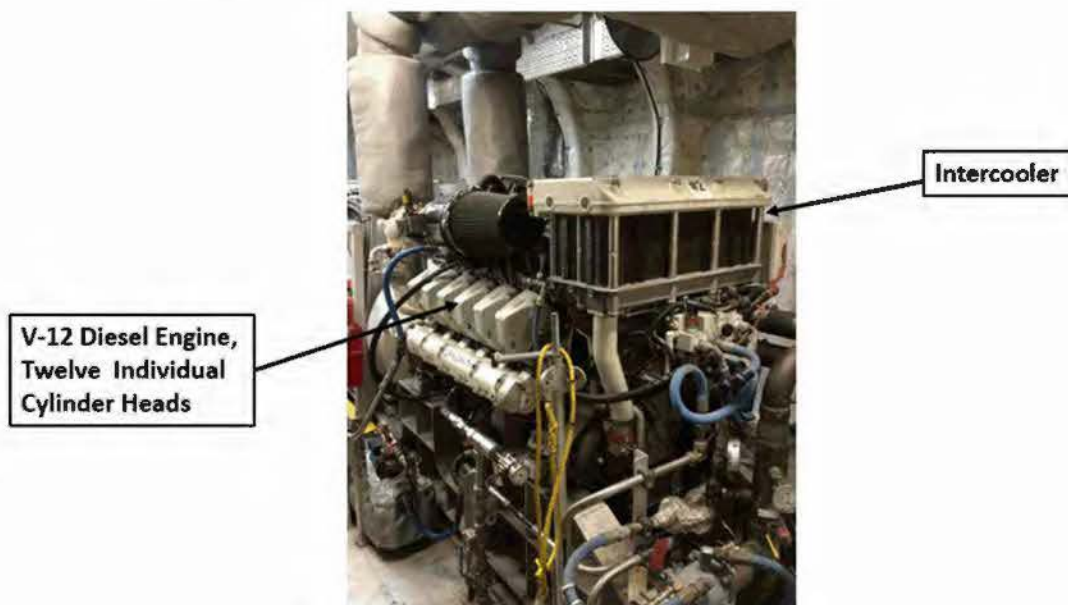
Figure 9. SSDG Number 2, USNS *Spearhead*

The SSDGs are turbocharged, relying on seawater-cooled intercoolers that have been leaking (Figure 9). Internal combustion engine power output is largely determined by the displacement of the cylinders. A normally aspirated engine relies on ambient air pressure to fill the cylinders with air and the fuel is added in proportion to the amount of air. Turbochargers, powered by exhaust gas from the running engine, are used to compress incoming combustion air so that more fuel can be injected and power output is increased. All turbocharged engines have an intercooler that cools the air after it is compressed and before combustion. For these engines,

the working fluid for the intercoolers is seawater. All four intercoolers had seawater leaks during this test period. USNS *Spearhead*'s SSDGs suffered heavy piston and valve train damage, likely a result of corrosion from exposure to seawater.

- Continue aggressively determining the root cause of ship service diesel generator casualties and fixing them fleet-wide.
- Evaluate whether repairs and alterations to the waterjet reversing buckets, along with alterations to the ship autopilot system, resolve the failure mode of this equipment, or, alternately, investigate a replacement schedule to minimize waterjet casualty downtime.
- Evaluate whether the repairs and alterations to the internal operating mechanism of the forward ride control foils resolves the failure mode.
- Complete structural reinforcement of bow structure on remaining ships of the class.

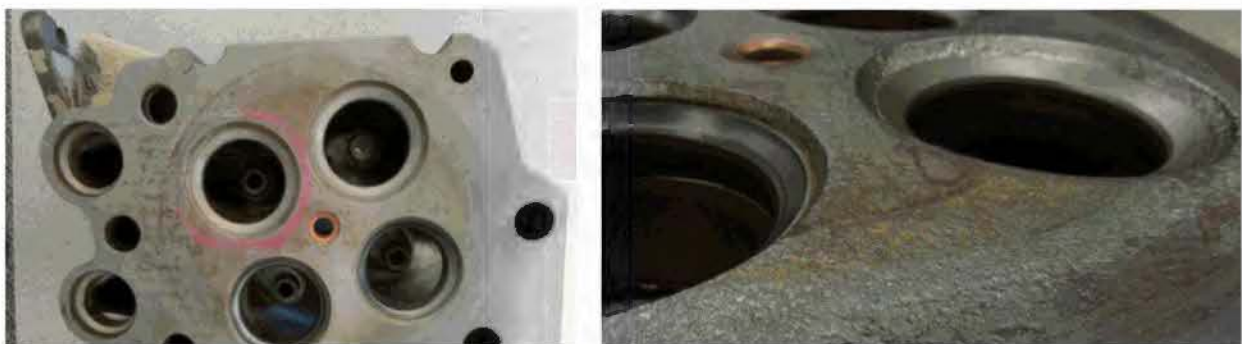
Figure 10. Flame Face Surface Pictures of SSDG Cylinder Head

Many of the individual cylinder heads (Figure 9) of the Fincantieri-manufactured SSDGs have developed cracks that allow engine coolant to leak into the cylinders. Each cylinder head contains four valves, two for fuel/air intake and two for exhaust. Manufacturing issues, both in head castings and assembly, are the cause for erosion and cracking of the heads. All 12 heads were replaced on two of four USNS *Spearhead* SSDGs during this test period. Figure 10 shows the flame face surface of one cylinder head and the close up of another cylinder head showing erosion. The same cylinder head in the close up has been sectioned to show an intake port in Figure 11. The right hand picture in Figure 11 shows a Magnaflux inspection that verifies the location of a crack in the intake bridge.

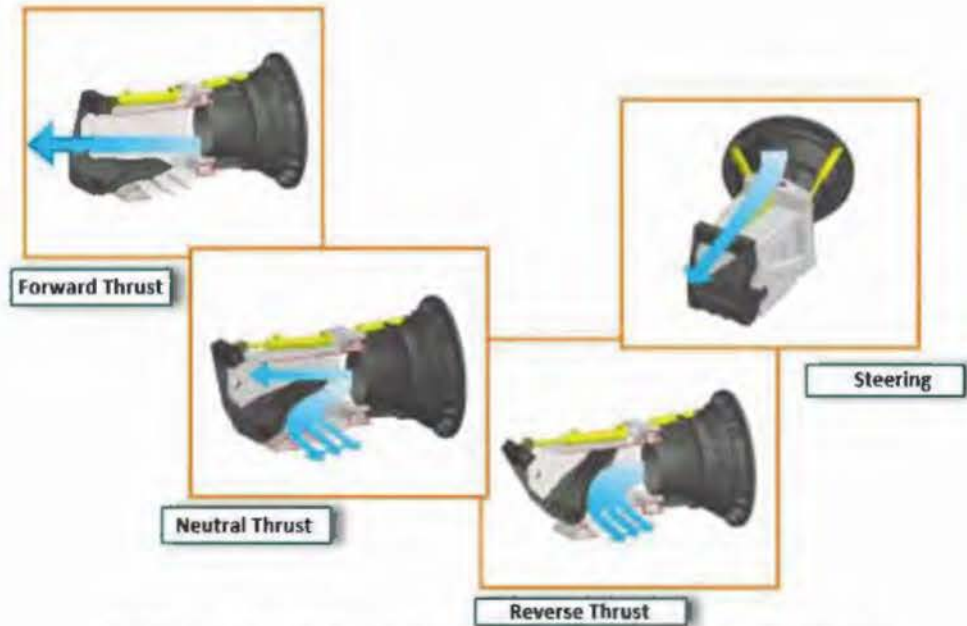
Figure 12. Ship Waterjet Positions for Various Directional Thrusts

All four waterjets suffered broken or failing reversing plates. The reversing plates are used to redirect the waterjet outlet flow to allow neutral thrust or reverse propulsion (Figure 12). An analysis by the waterjet manufacturer suggests the failure of the reversing plates was due to high-cycle, low-load, bending fatigue.⁵ A sideways loading is suspected to have caused the failures. When not positioned for neutral or reverse propulsion, the plate stiffeners interact with the water flow as the ship is moving forward in the water. As shown in Figure 12 below, the waterjet is set for forward thrust and the underside of the reversing plate is exposed to water flow proportional to the ship's speed through the water. In Figure 13, the modeled reversing plate shows three plate stiffeners that are highlighted in red. The loading that is suspected to have caused the failures is caused by a sideways force on these plate stiffeners. Modifications have been made to the reversing plates to lessen the sideways force by as much as two-thirds. Additionally the weld around the lower support tube in Figure 14 has been machined to a smooth surface so that the stresses are not amplified by small fluctuations of the weld surface. Figure 15 shows close ups of this weld. The autopilot control has been modified to lessen the cycling of the jets side to side as the ship maintains heading, which is intended to reduce the number of load cycles and further delay the initiation of any fatigue cracks.

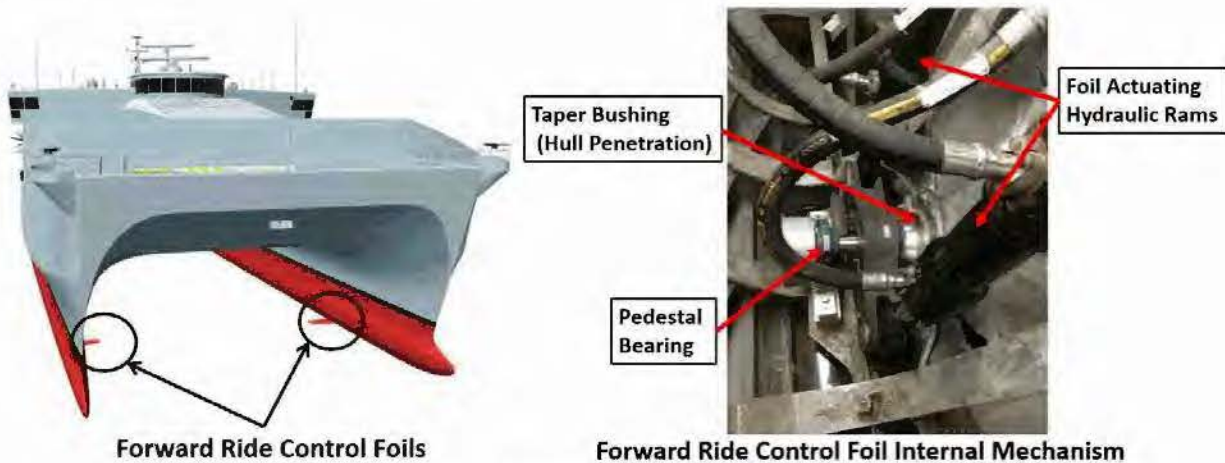
Figure 16. JHSV Forward Ride Control System (RCS)

The USNS *Spearhead* RCS has suffered failures of the internal mechanism for the forward foils. The JHSV ship class uses a RCS that provides active pitch/roll damping using four control surfaces, two forward and two aft. The system is designed to not only smooth out the ride, but to limit structural loading on the ship bow. It is required to be operational for ship speeds greater than 15 knots. Even with the RCS operating, the ship is limited in speed through the water both by sea state and orientation of the seas. Figure 16 shows the location of the two forward ride control foils and the internal mechanism for one of these that holds the foil in place and positions it. The aft RCS consists of two hydraulically actuated, horizontal foils that interact

with the flow of water passing under the ship in the vicinity of both the port and starboard waterjets.

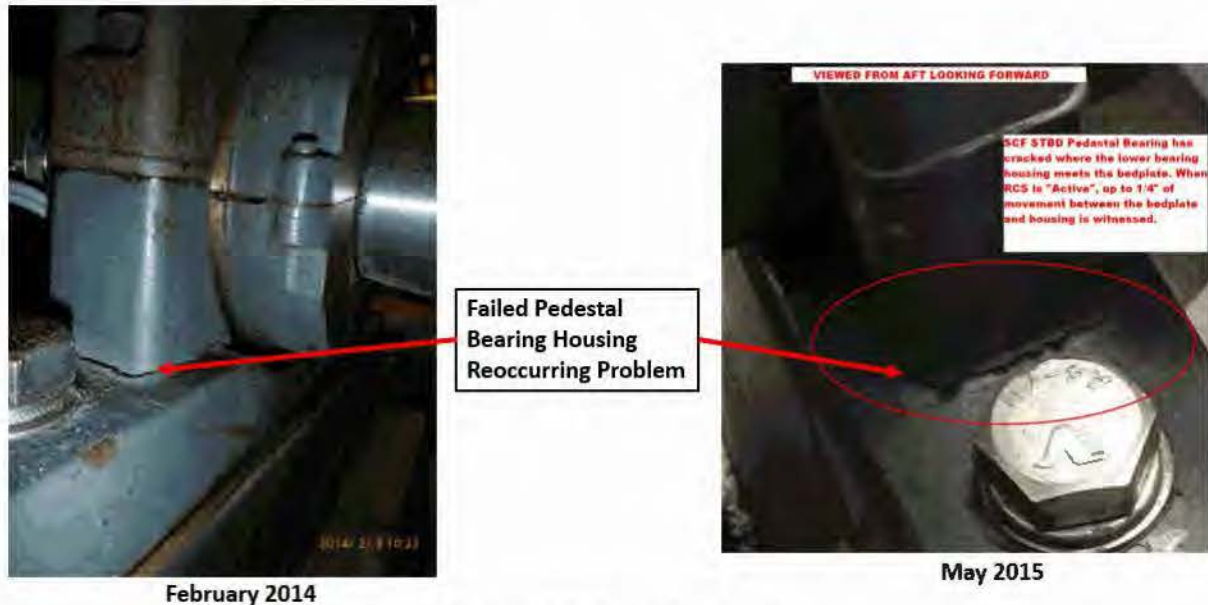
Figure 17. Failed Pedestal Bearing Housing

Several structural issues with the RCS forward foil mechanism have required repairs. Figure 17 shows failed pedestal bearing housings from 2014 and 2015. Alignment problems have prompted machining, shimming, and re-boring of holes for the base bolts of this bearing structure. The taper bushing assembly shown in Figure 16 has also drawn concern both for fit of the pieces and under-torque of the bolts holding it in place.

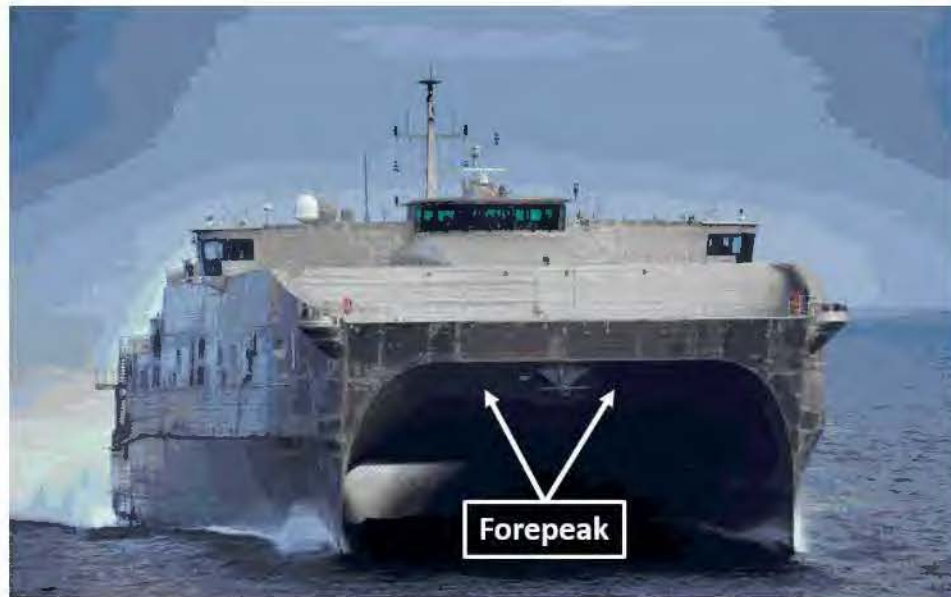
Figure 18. JHSV Forepeak

The entire ship class requires reinforcing structure for the bow structure in the forepeak space, which is the forward structure of the ship between the two hulls, as shown in Figure 18. The American Bureau of Shipping originally recommended that the bow structure in the

forepeak area be built to withstand 26.1 pounds per square (psi) loading caused by wave slamming. The ship manufacturer, Austal USA, proposed a revised Safe Operating Envelope (SOE) to eliminate the likelihood of head seas and recommended a design to withstand pressures up to only 17 psi. The ship design manager approved the Austal USA proposal and the Navy Program Manager concurred.

Hulls 1 through 4 have been repaired and reinforced, adding an additional 1,736 pounds to the ship's weight. This should have minimal impact to ship mission capability in regards to fully loaded range capability. From the IOT&E report, when the ship is fully loaded with troops and equipment (600 short tons), the ship's fuel tanks cannot be completely filled with fuel. The additional weight from the added bow structure displaces 250 gallons of fuel, which correlates to 3.5 nautical miles of reduced range at 31 knots (reduced to 854 nautical miles).

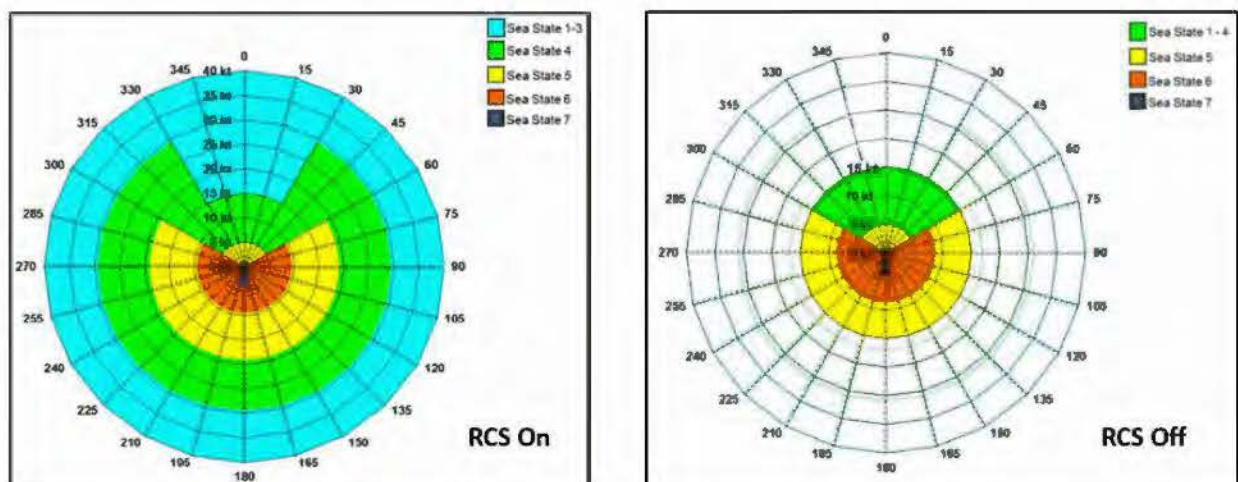
Figure 19. JHSV Ship Class Safe Operating Envelope (SOE)

The decision to accept a limiting SOE and build the ships to withstand only 17 psi loading from wave slamming has resulted in a ship class that is easily damaged. The SOE defines allowable speeds in varying sea states and angle of wave motion to ship's heading. Figure 19 shows the ship class SOE with and without an operational RCS. Operating the ship outside of the SOE or encountering a rogue wave that is outside of the current sea state can result in sea slam events that cause structural damage to the bow structure of the ship. Figure 20 shows internal bent scantlings in the forepeak area of JHSV 1.

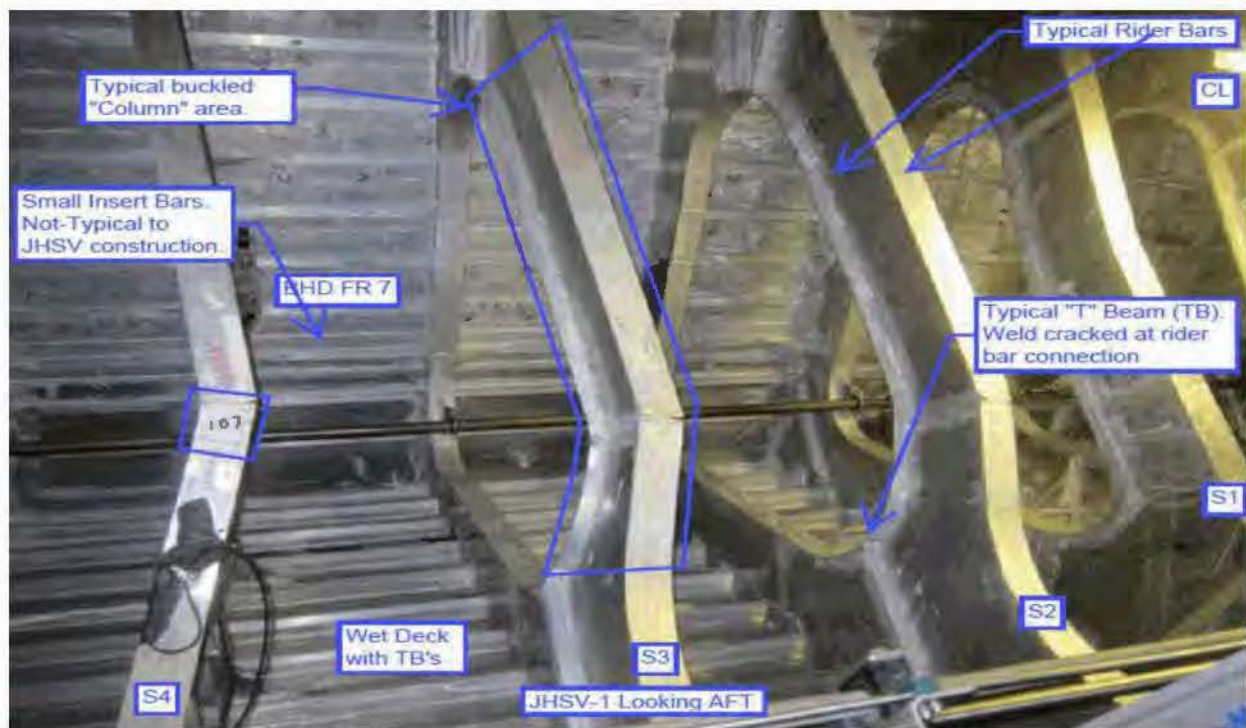
Figure 20. Internal Bow Damage in Forepeak Space, JHSV 1

The RCS failures are a symptom of a more serious problem with the JHSV ship design. Compromises in the bow structure, presumably to save on weight, were accepted when building these ships. Multiple ships of the class have suffered damage to the bow structure and repairs/reinforcements are in progress class wide. The reinforcement of the bow structure does not expand the SOE but should allow full use of the ship, within the original SOE, without risk of damage.

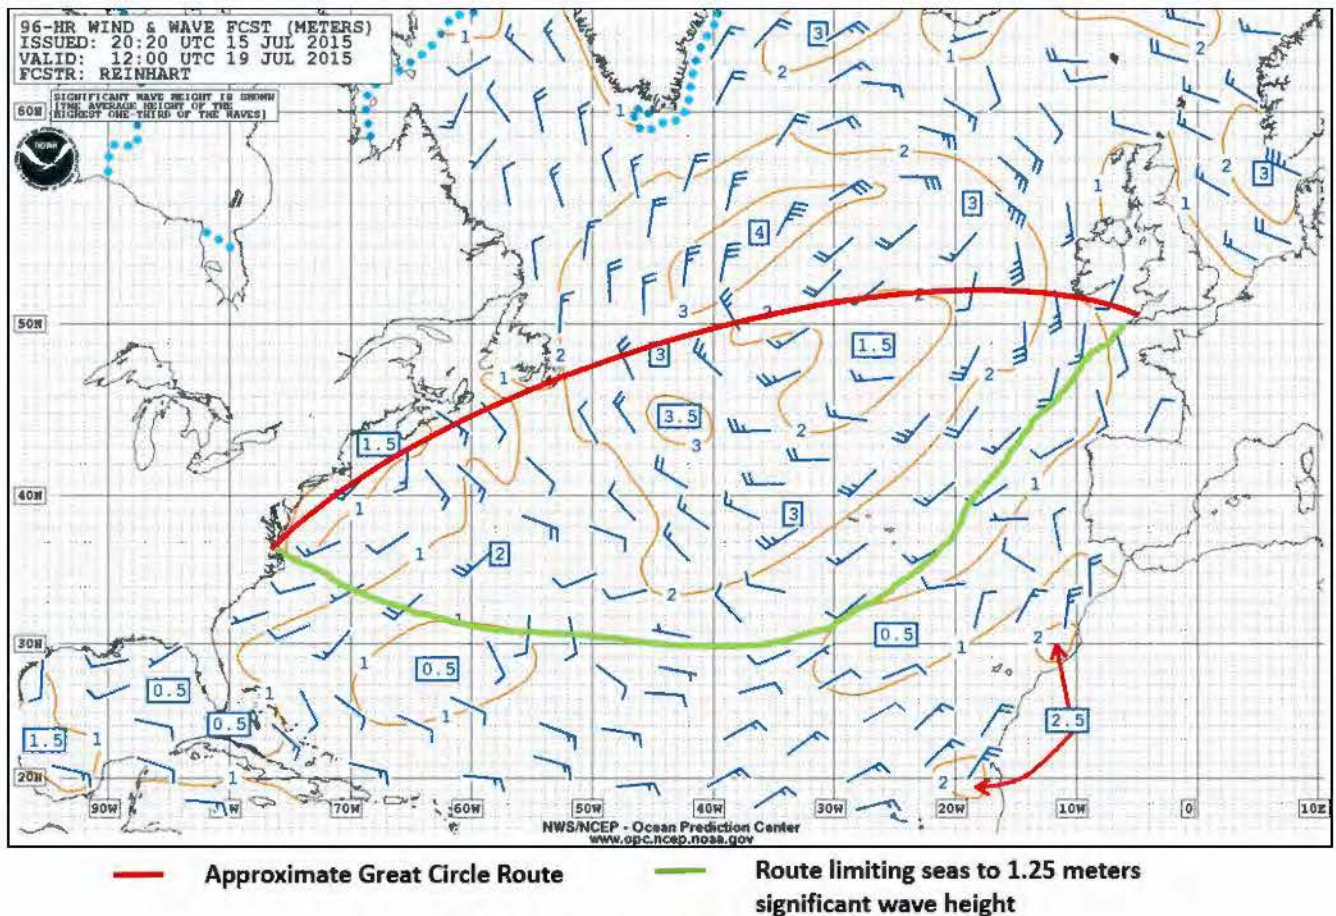
Figure 21. Routes across the Atlantic

The necessity of avoiding high sea states while transiting is a potential operational limitation that was not examined in the IOT&E report. At wave heights of 2 meters, the ship needs to slow to 15 knots or less, and at 3 meters, the ship can transit at only 5 knots or less. Figure 21 is a 96-hour wind/wave forecast for the Atlantic Ocean from July 15 – 19, 2015, from the National Oceanic and Atmospheric Agency. The red arc is an approximate great circle route, (shortest distance) between Virginia and England. Of note are the wave heights along this route, ranging from 1 meter to 3 meters. The green route adds a significant distance to the transit but keeps to seas with significant wave heights of 1.25 meters or less (Sea State 3 and below) and allows higher transit speeds while staying within the SOE for the ship. These sea state limitations are always a concern for this ship.
