Subj: (U) REPORT OF THE INVESTIGATION INTO THE FACTS AND
CIRCUMSTANCES SURROUNDING THE ACCOUNTABILITY FOR, AND
SHIPMENT OF, SENSITIVE MISSILE COMPONENTS TO TAIWAN

FINAL REPORT

INVESTIGATION INTO THE SHIPMENT OF SENSITIVE MISSILE COMPONENTS TO TAIWAN (U)

MAY 22, 2008

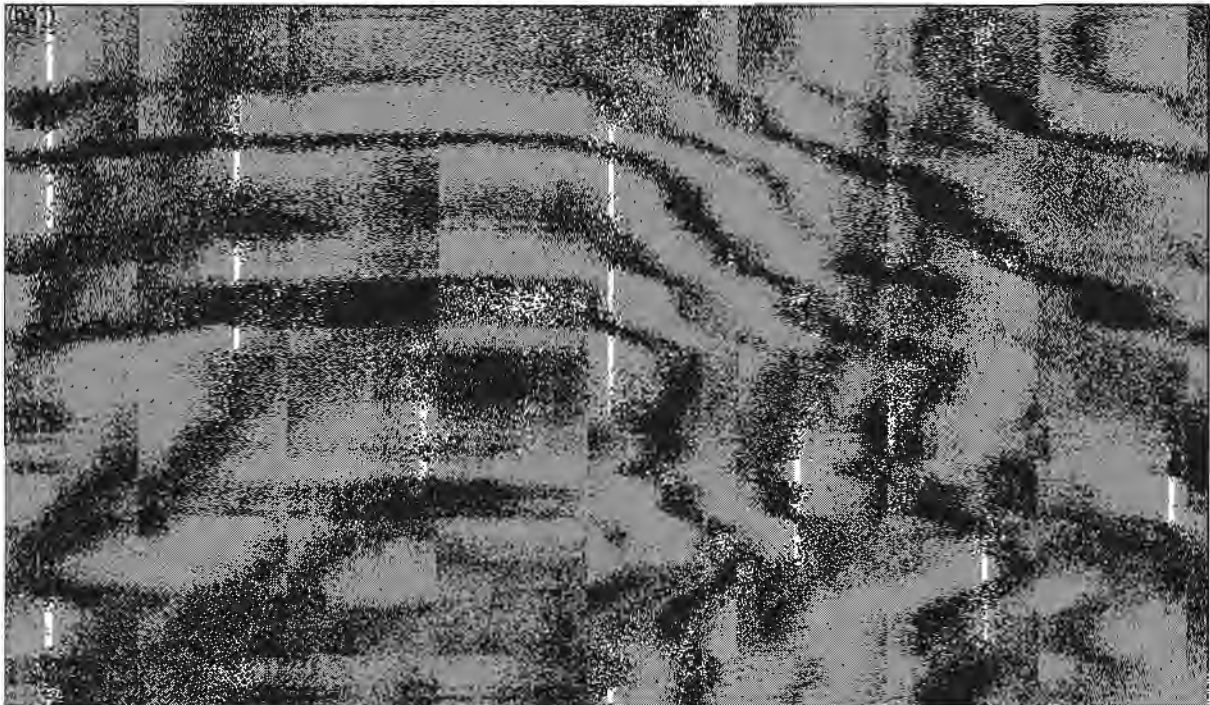
Figure 2 – DDHU REPSHIP File (U)

(c) (U) DDHU's file of REPSHIPS for pending classified receipts was not organized by date or auditable. Further, it was not purged to reflect shipment arrivals (see Figure 2 below). The condition of the file limited its effectiveness in confirming receipt of and maintaining control over classified shipments.

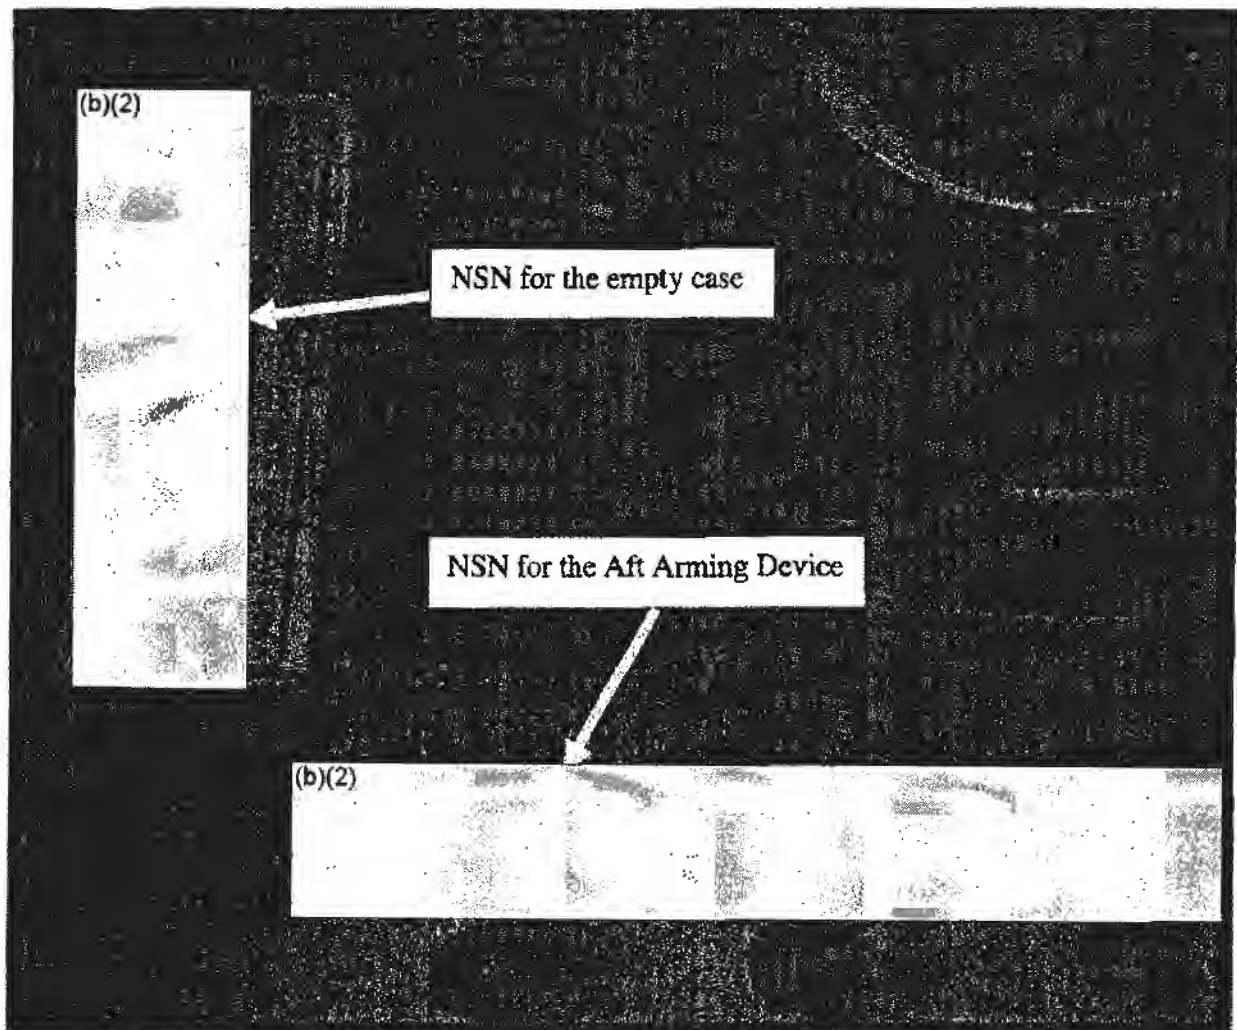
Figure 4 – Aft Arming Device (U)

(d) (U) Several missile component kits were not catalogued to facilitate easy identification of the assemblies. The complex method of cataloguing required a degree of technical understanding, beyond the training provided to receiving custodians, to accurately receive and inventory the components. Additionally, identifying both individual component and assembly or kit NSNs of a single component required a degree of technical knowledge to properly identify, warehouse, and control these components. As a result, effective material control of the components was compromised. For example:

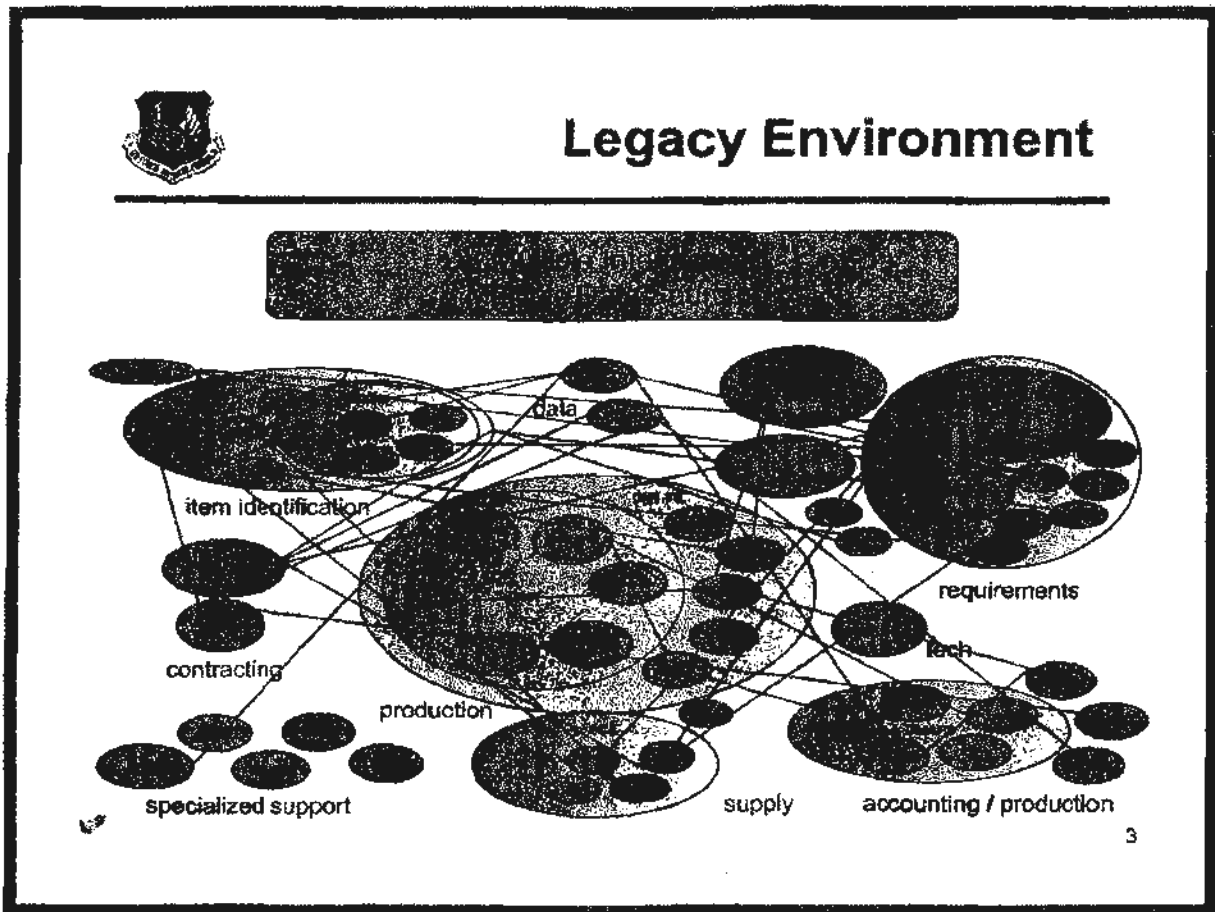
Figure 6 – Supply Chain Information Technology Systems (Source: AFMC/A4)
(U)

(a) (U) While Figure 5 depicts a relatively simple process flow, according to AFMC, the Air Force supply chain management system is a loosely knitted conglomeration of applications that were independently developed over time. As a result, the interfaces between these legacy applications are complex, difficult to maintain, and require an experienced IMM to use effectively (see Figure 6 below).
