SUBJECT: Emergency and Extraordinary Expense Request - Kunduz Hospital (U)

Project Title: Kunduz Repair Hospital

According to the given instruction, ATS team creates this report as a final product. This report indicates mandatory information that presents (MSF) Hospital of Kunduz, the Update / actual plans, site photos, existing facilities and existing Utility condition. The following details are guides for more assistance and well understanding of this report which are:

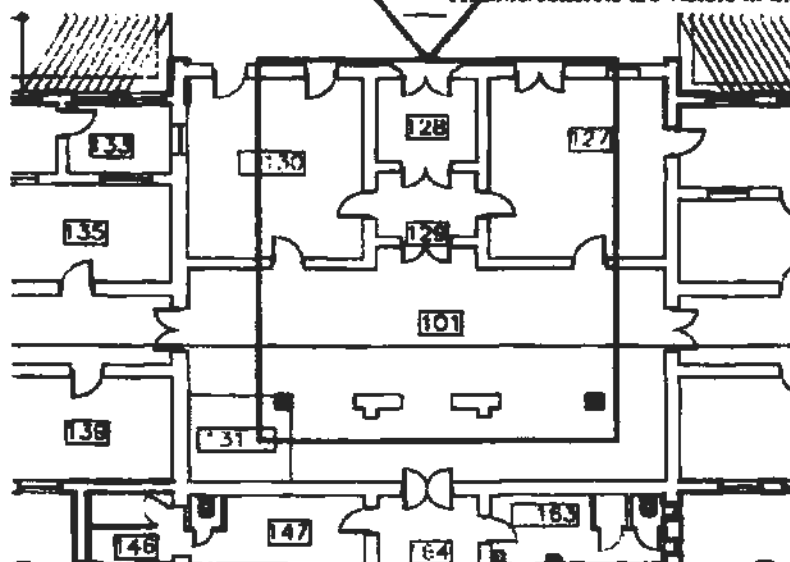
Photo #38

Location: MSF Hospital, Wing B, North entrance, Room #128, 129, 101

Report: Structurally the building has been constructed with brick masonry and wooden beams with roof sheeting. Fall ceiling, wall plaster, floor ceramic/concrete are visible in this wing.
