OPERATIONAL TEST
AND EVALUATION

SUBJECT: Observations on the Marine Corps F-35B Demonstration on USS *Wasp*

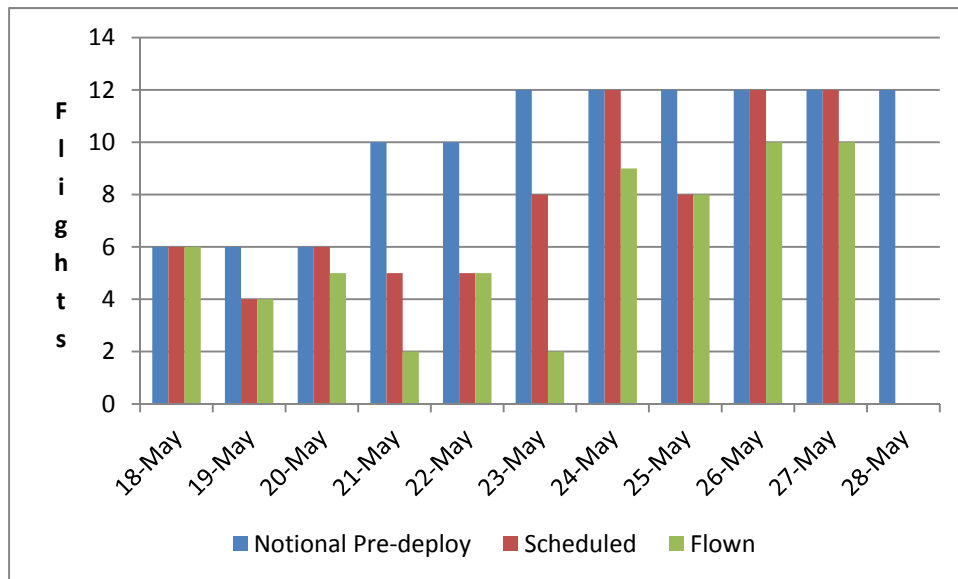
Figure D-1. Daily Flight Activity

can be made to a notional air plan that was developed during a pre-deployment planning conference in March 2015. The figure below shows the day-by-day comparison between the notional number of flights envisioned as of the pre-deployment planning conference; the actual number of flights scheduled each day, which was designed around aircraft availability; and the actual number of flights accomplished. Two flights were cancelled due to lightning within the limits of an existing F-35 operating restriction and two nighttime Carrier Qualification (CQ) events were canceled for weather that was anticipated to be outside acceptable limits for CQ operations. The other 13 flights scheduled but not flown appear to have all been omitted for aircraft availability.

- The daily flight schedules during the shipboard deployment period were written to accommodate the anticipated aircraft availability each day, as is standard practice in any squadron. Although the aircraft availability cannot be predicted, a comparison

- The average utilization rate on a flight basis was less than one flight per aircraft per day, including the ferry flights to the LHD, for the 11 days from May 18 to 28 (including one down day for maintenance to prepare the aircraft for the redeployment). Aircraft utilization was not uniform across aircraft or throughout the time of the deployment. Initial plans were for the number of flights to increase as the deployment progressed; however, flight schedules had to be adjusted daily based on anticipated aircraft availability. The highest utilization rate occurred on May 26 and 27 (days 9 and 10 the deployment underway at sea), at nearly 1.67 flights per aircraft assigned per day.

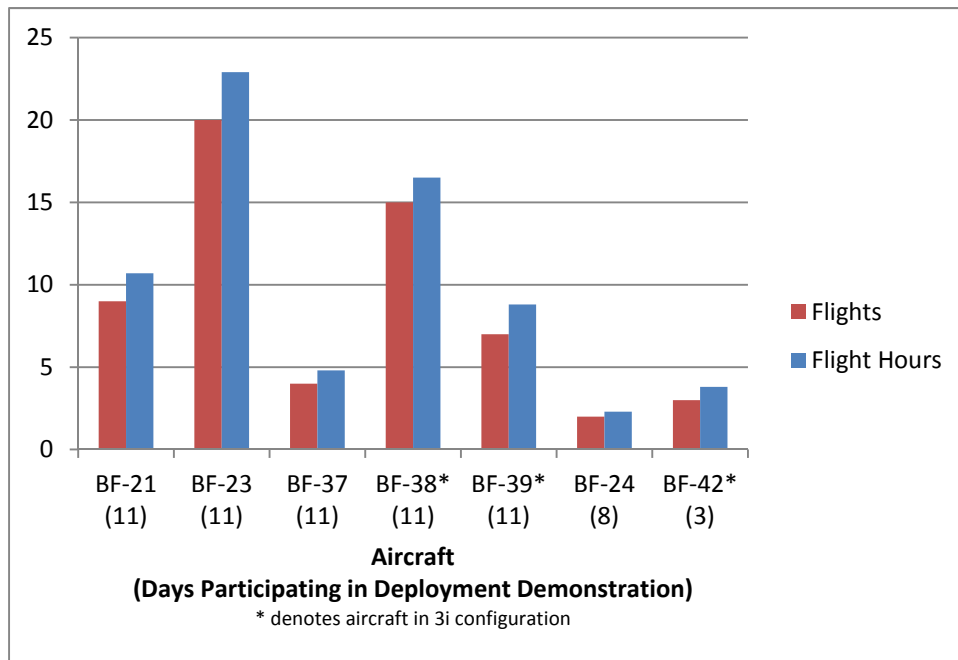
Figure D-2. Aircraft Flights and Flight Hours

- The number of flight hours flown by each aircraft varied widely, with some aircraft in a down status for up to five days in a row, and other aircraft rarely requiring major maintenance. BF-23 performed best, accumulating roughly 23 flight hours over 20 flights, and was the only aircraft to be scheduled and flown every day while underway. Of the remaining four aircraft that completed the entire deployment, BF-37 flew the least, with approximately five hours and four flights, including the fly-on from MCAS Beaufort and a ferry flight to return from MCAS Cherry Point after diverting there. Due to multiple maintenance issues, BF-37 did not fly from May 19 through May 23, flew on May 24, but emergency diverted to MCAS Cherry Point, and then returned to the ship on May 26. It did not fly on May 27 for a maintenance issue, and only flew again on May 29 to ferry off the ship. The figure below shows the flights flown and flight hours accumulated for each of the aircraft that participated in the deployment.
