**RQ-21A Blackjack  
Small Tactical Unmanned Aircraft System  
(STUAS)**

**Initial Operational Test and Evaluation Report**

**June 2015**

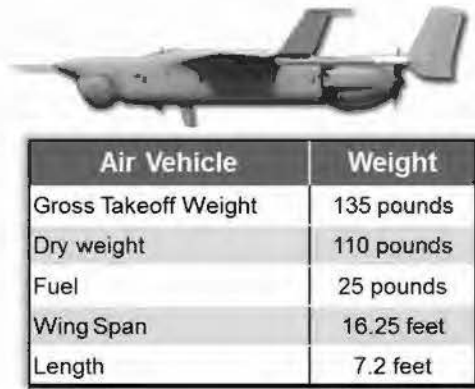
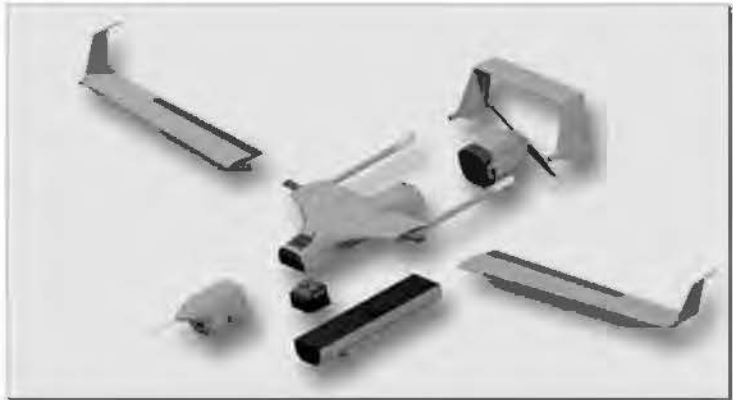
**Figure 1-2. RQ-21A Air Vehicle**

The air vehicle is a modular system, composed of small easily assembled line replaceable units. It has a multi-function ball turret that houses mission sensors, and various connection points and bays for custom payloads (see Figure 1-2). The air vehicle is capable of taking off and landing without a runway via the launch and recovery systems. The air vehicle is powered by a two-cylinder, two-stroke, 100 cc electronically fuel-injected engine that operates on JP-5 (military aviation jet fuel) and equivalent fuel types (with the addition of a special synthetic lubricating oil additive).

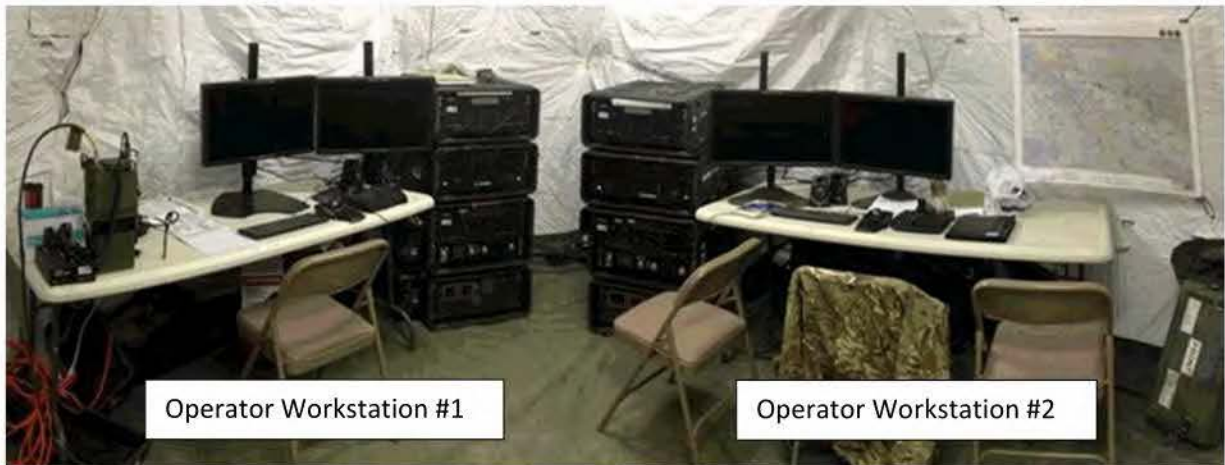
**Figure 1-3. Tabletop Ground Control Station Configuration**

The ground control station (GCS) is used to plan missions, control and monitor the air vehicle, and manage data received from the air vehicle. Figure 1-3 shows the tabletop ground control station configuration used during operations at Marine Corps Air-Ground Combat Center Twentynine Palms. The GCS includes two operator workstations, two ground data terminals for air vehicle command and control and video downlink, and a Global Positioning System (GPS) Electronics Module. Air vehicle operators control the air vehicle and multi-function ball turret through the GCS.

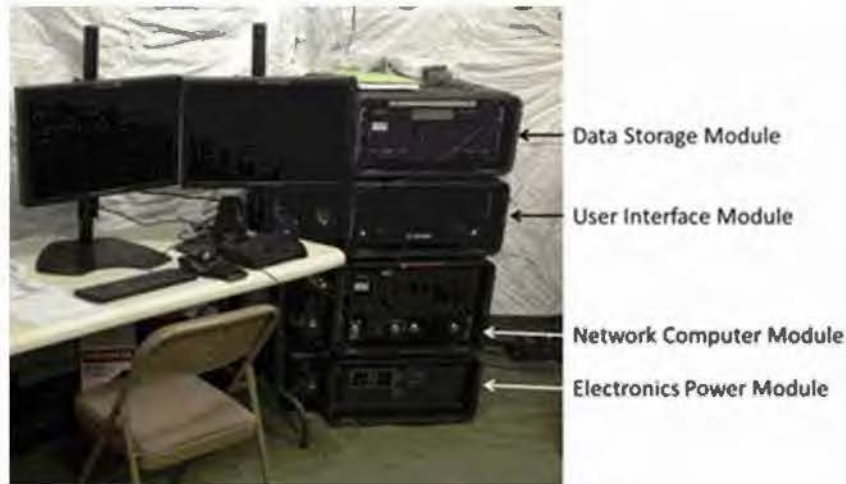
**Figure 1-4. Operator Workstation**

Each operator workstation consists of four modules: the electronics power module, network computer module, user interface module, and the data storage module (see Figure 1-4).

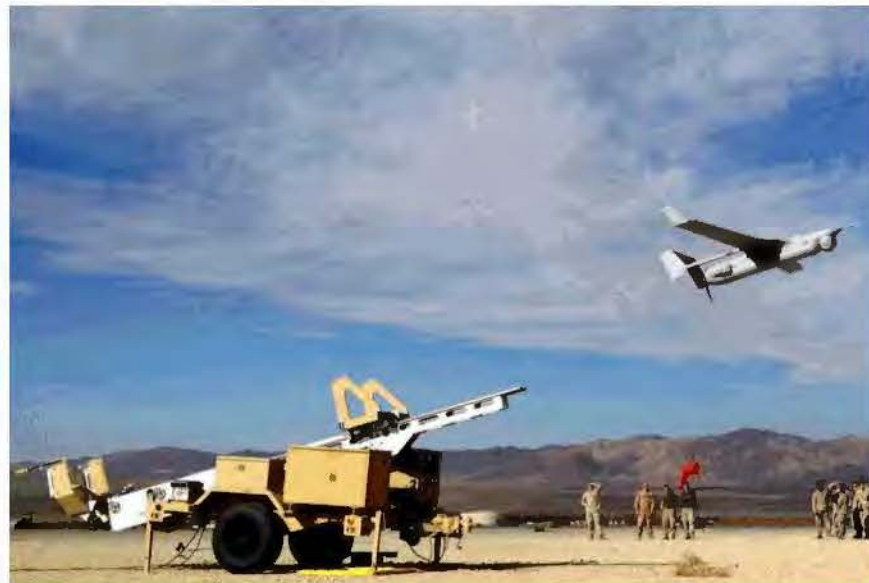
**Figure 1-5. The RQ-21A Launcher**

The RQ-21A launcher is a pneumatically-controlled device that accelerates the air vehicle to flight speed at takeoff and enables expeditionary employment of the RQ-21A in austere conditions without runways (see Figure 1-5). The launcher system is self-powered and designed for transport by air (via CH-53 helicopter, C-130 aircraft, and C-17 aircraft) or by land (towed by HMMWV).

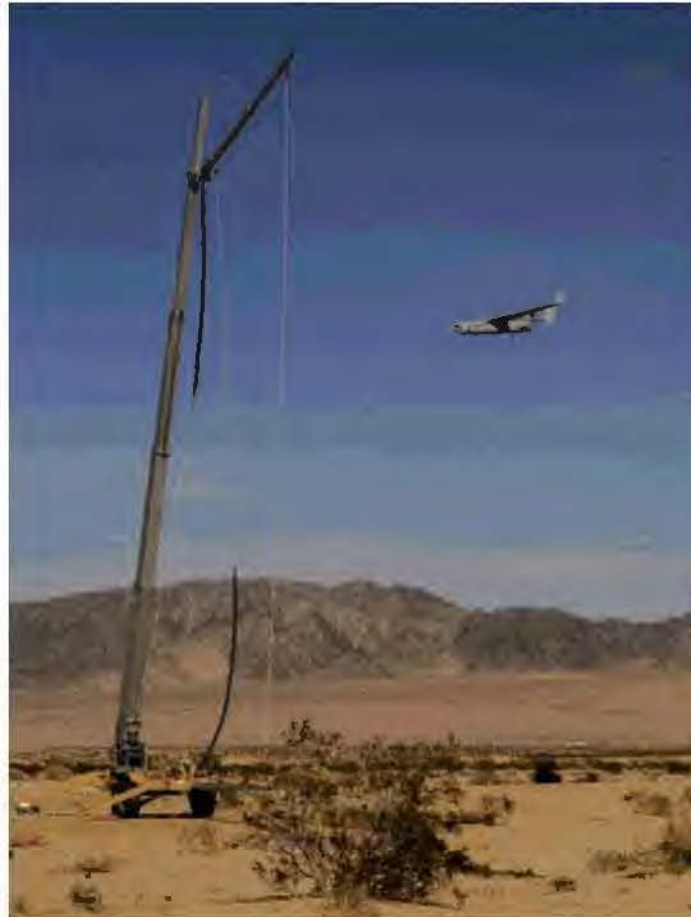
**Figure 1-6. RQ-21A Recovery System**

The RQ-21A recovery system employs a telescoping hydraulic mast and boom system that suspends a rope to capture the air vehicle in mid-flight (see Figure 1-6). After the rope captures the air vehicle, the air vehicle spins about the rope down to the ground. The recovery system mounts on a modified tactical Military Standard (MIL-STD) trailer chassis with an engine-driven hydraulic power unit. External electrical power and fiber optic signal cables are required to support the GPS electronics module onboard the RQ-21A recovery system.

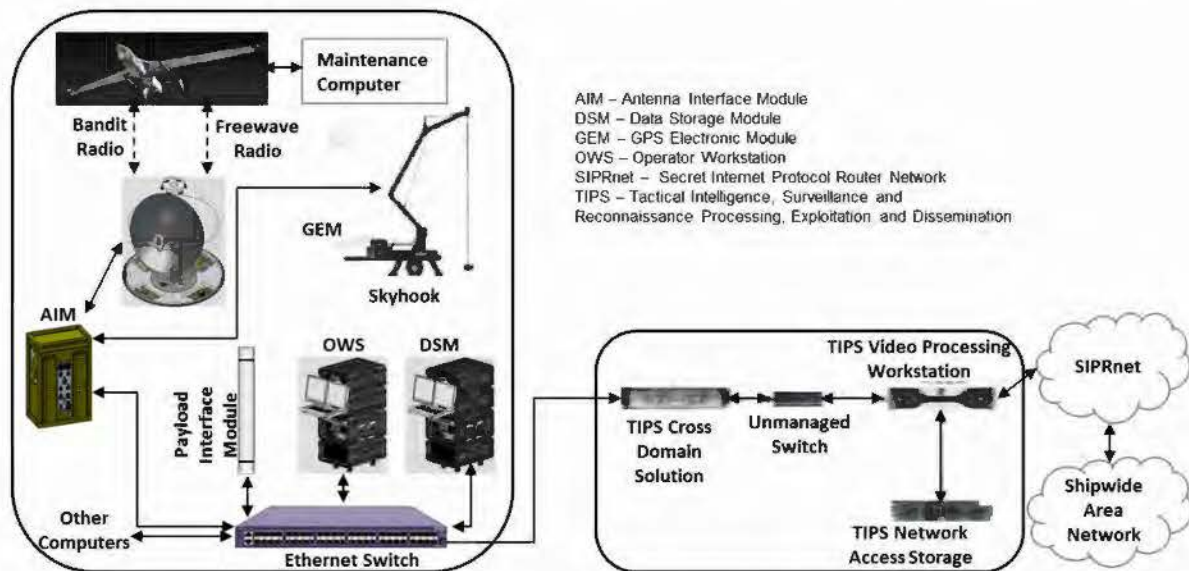
Figure 2-1. RQ-21A Architecture

COMOPTEVFOR, working with the Navy Information Operational Command-Norfolk, conducted cybersecurity testing of the sea-based system aboard USS *Anchorage* (LPD 23). This test period assessed the operator workstations and TIPS, in addition to the antenna interface module, the maintenance laptop, and the air vehicle. Testers attempted to penetrate the RQ-21A system externally through the Fleet Network Operations Center, Automated Digital Network System, and Shipboard Wide Area Network. The air vehicle remained grounded during cybersecurity testing for flight safety reasons. Figure 2-1 shows the RQ-21A cybersecurity architecture.

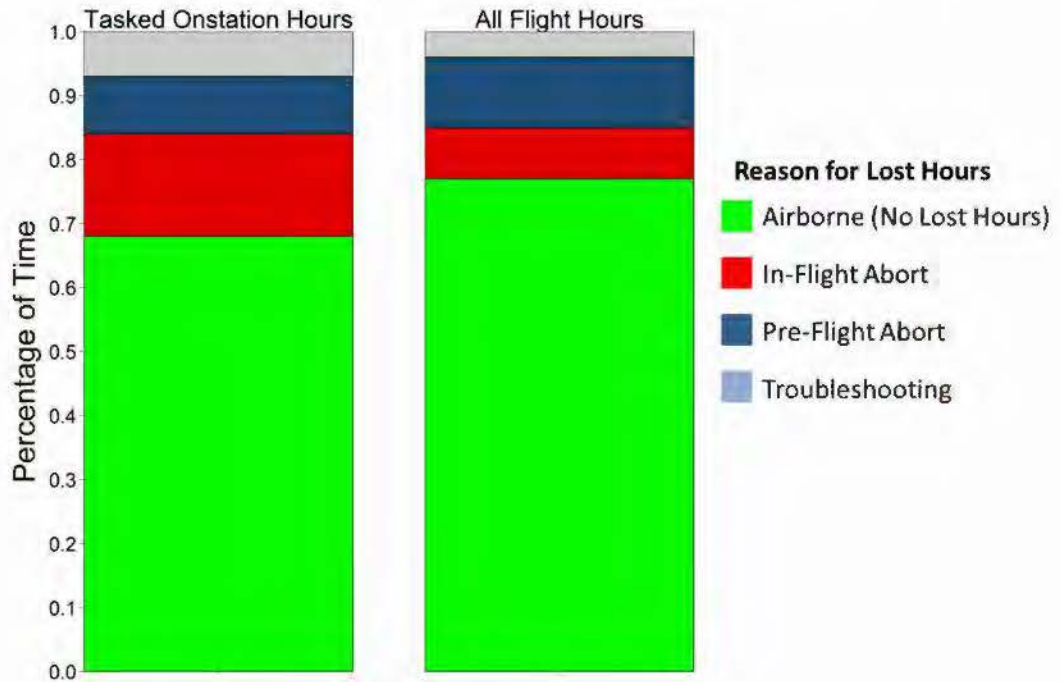
Figure 3-1. Mission Coverage

RQ-21A flew 77 percent of scheduled flights hours (233.6 of 301.7, see right side of Figure 3-1). Unlike the Mission Coverage metric, this number considers all flight hours

scheduled across the entirety of the IOT&E. This includes the tasked on-station times, transit times to and from the on-station location, training flights, and flights to collect specific operational test data points. In this case, pre-flight aborts caused the greatest loss of 33.9 flight hours (11.2 percent), followed by in-flight aborting failures, which caused a loss of 23.4 hours (7.7 percent), and in-flight troubleshooting, which caused a loss 10.7 hours (3.6 percent).

- RQ-21A failed to support 20.1 hours (16.4 percent) of the on-station hours because of in-flight aborting failures that caused an early return to base.
- Pre-flight aborting failures that delayed or cancelled launches resulted in the loss of 10.7 hours (8.7 percent) of the on-station flight hours.
- In-flight troubleshooting of sensor anomalies caused the loss of the final 8.1 hours (6.6 percent) of on-station hours.

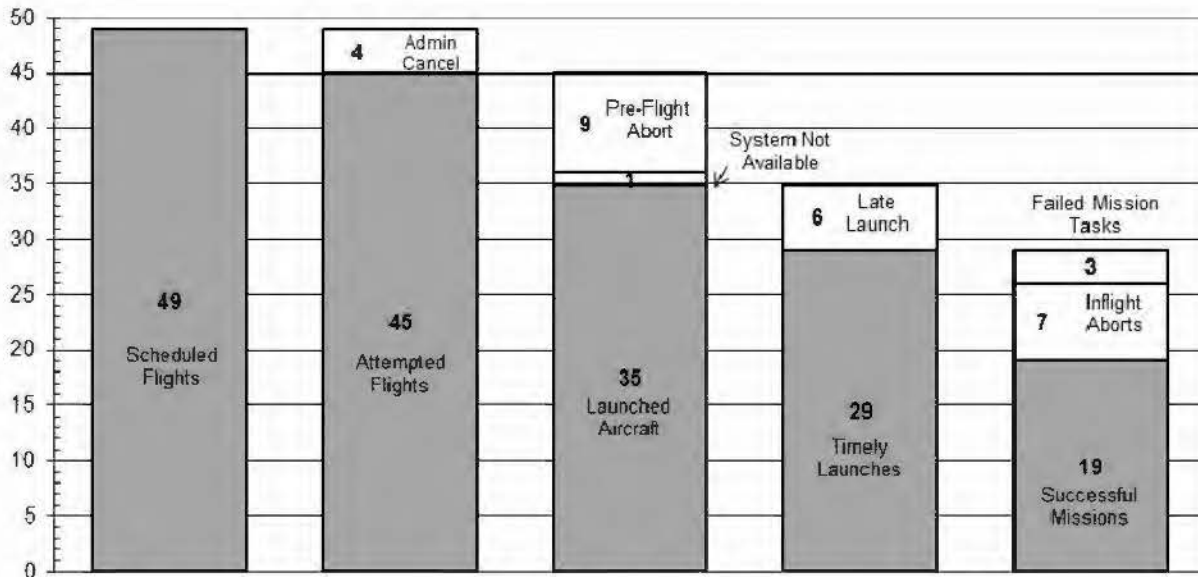
**Figure 3-2. Mission Completion Rate**

The RQ-21A demonstrated a low probability of successfully completing realistic missions during IOT&E. As shown in Figure 3-2, 19 of 45 attempted flights (42 percent) launched on time, supported assigned tasking, and remained on station for the duration of the assigned period. Of the 45 attempted launches, 35 (78 percent) provided some level of utility to ground commanders (launched at some point and provided some on-station time).

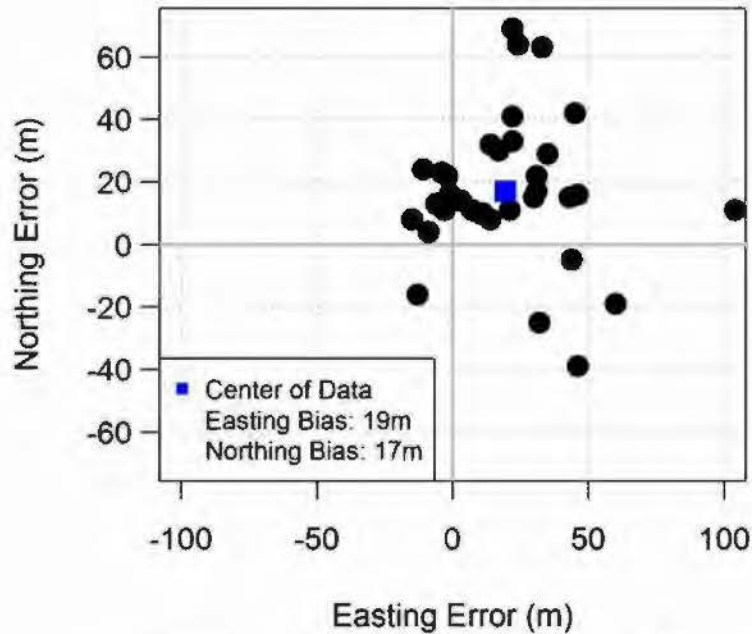
**Figure 3-3. Sensor Point of Accuracy Data**

Target locations reported by RQ-21A operators showed a systematic error, consistently reporting target locations as further east (on average, 19 meters) and further north (on average, 17 meters) than actual locations (see Figure 3-3).

RQ-21A target locations provide Category IV accuracy as defined in Joint Publication 3-09.3, *Close Air Support* (31–90 meters). Such accuracy is sufficient to support targeting in a conventional, linear battlefield, where less target location accuracy is required for successful target engagement. This accuracy does not support targeting in a dense urban environment that requires more accurate target locations.

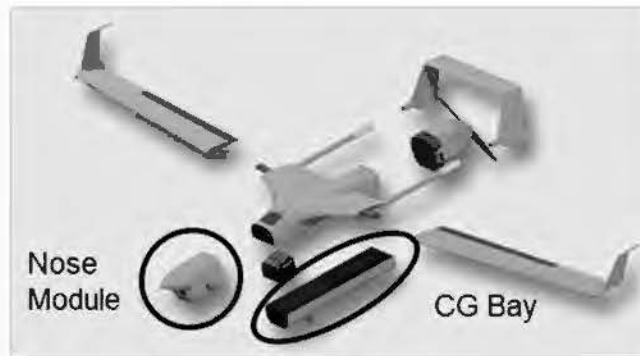
**Figure 3-4. Air Vehicle Payload Modules**

The modular air vehicle design allows for payload changes within the 60-minute Modular/Interchangeable Payload KPP threshold. Build-up of an entire air vehicle takes 20 minutes. As shown in Figure 3-4, the air vehicle carries payloads in one of two modules: the nose module or the Center of Gravity (CG) Bay.

The electro-optical/infrared sensor mounts to the nose module. The CG Bay carries the communications relay payload and the automatic identification system. The CG Bay will carry additional payloads in the future provided they have the appropriate interface connections.

Maintainers are able to remove and replace the nose module or the CG Bay well within the required 60-minute threshold. The nose module connects to the air vehicle fuselage with eight bolts and has a pneumatic tubing connection for the pitot systems and a serial port type connection to the avionics module. The CG bay connects to the air vehicle fuselage with eight bolts and a single power connection to the avionics module.

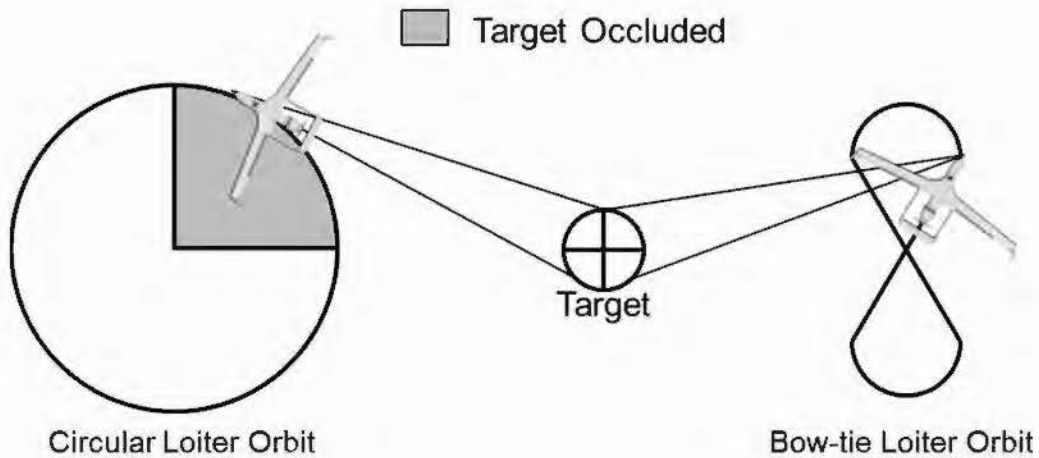
**Figure 3-6. Air Vehicle Orbits**

As shown in Figure 3-6, there are orbit shapes that allow RQ-21A operators to maintain continuous coverage of a target from an offset orbit. The so-called “bow-tie” orbit solves the fuselage blocking the payload issue while maintaining continuous target coverage. As currently designed, the RQ-21A operating system limits operators to circular orbits. An experienced air vehicle operator was able to execute a bow-tie orbit by manually moving a circular orbit back and forth as the payload approached the fuselage blocking point. This manual bow-tie pattern requires an increased workload that prevents the operator from performing any other task during its conduct.

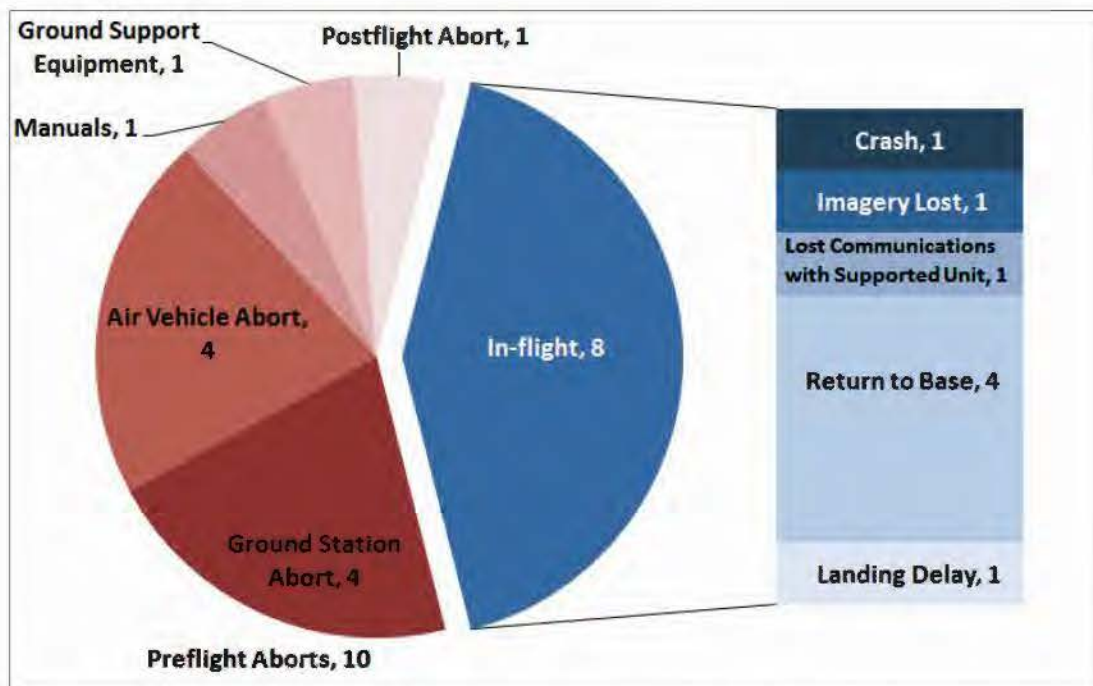
**Figure 4-1. Aborting Failure Breakdown**

Figure 4-1 shows the breakdown of aborting failures. Eight of the 19 failures occurred with the air vehicle in flight, resulting in mission aborts as follows:

- Because of a mission computer reset during launch, one air vehicle was destroyed upon recovery.
- Four failures required the air vehicle to return to base and abort the mission. These failures included a tachometer generator failure alarm, propulsion module unit cylinder head temperature discrepancy, and two cases of lost link.
- An air vehicle modem and an operator workstation networking issue caused the two lost link events.
- While the air vehicle was attempting to land, the Differential Global Positioning System failed, delaying recovery by 97 minutes. Had this failure occurred during a longer flight, when the air vehicle was returning with less fuel, this could have led to a crash.

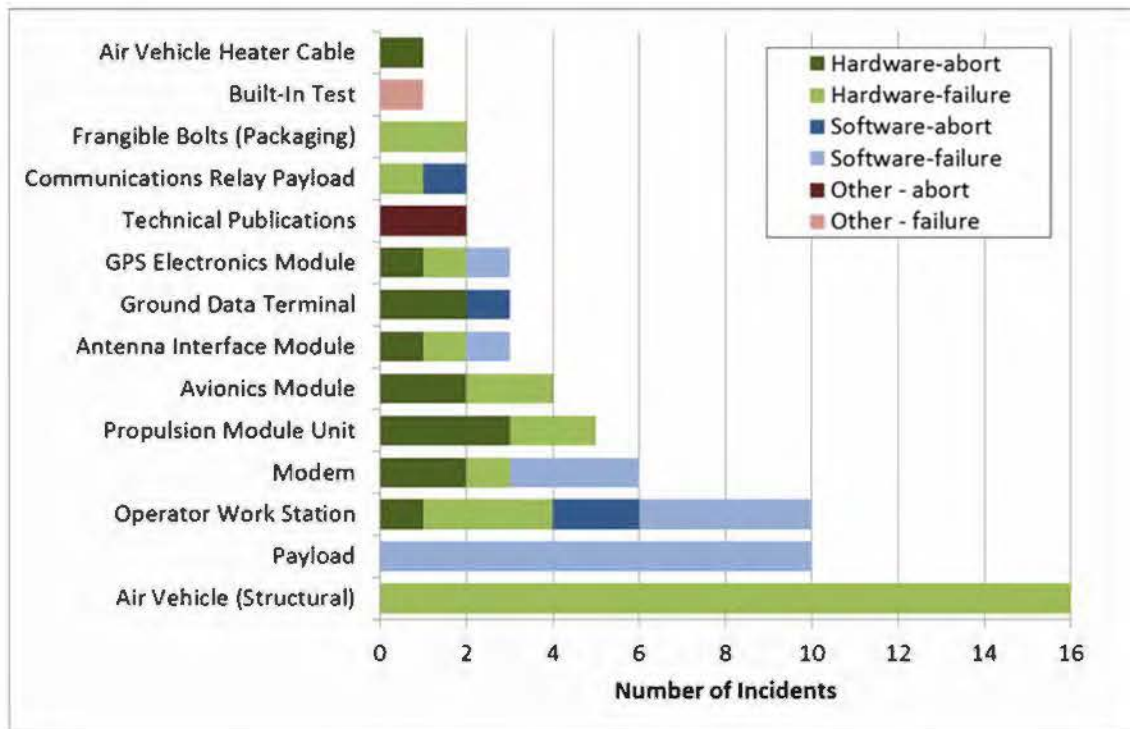
Figure 4-2. Failure chargeability

The four most common failure modes accounted for 54 percent (37 of 68) of all failures.

- Structural damage to the air vehicle accounted for 23 percent (16 of 68). The forces experienced by the air vehicle during capture with the recovery system cause parts to break. This damage ranged from hinge clips to replacement of entire wing and empennage modules.
- Payload software accounted for 15 percent (10 of 68) of the failures. Operators remedied these failures, such as pixilated imagery, loss of payload control, and the payload slewing away automatically, by resetting payload software.
- Nine percent (6 of 68) of failures were operator workstation software.
- Propulsion module units contributed 7 percent (5 of 68) of all failures.

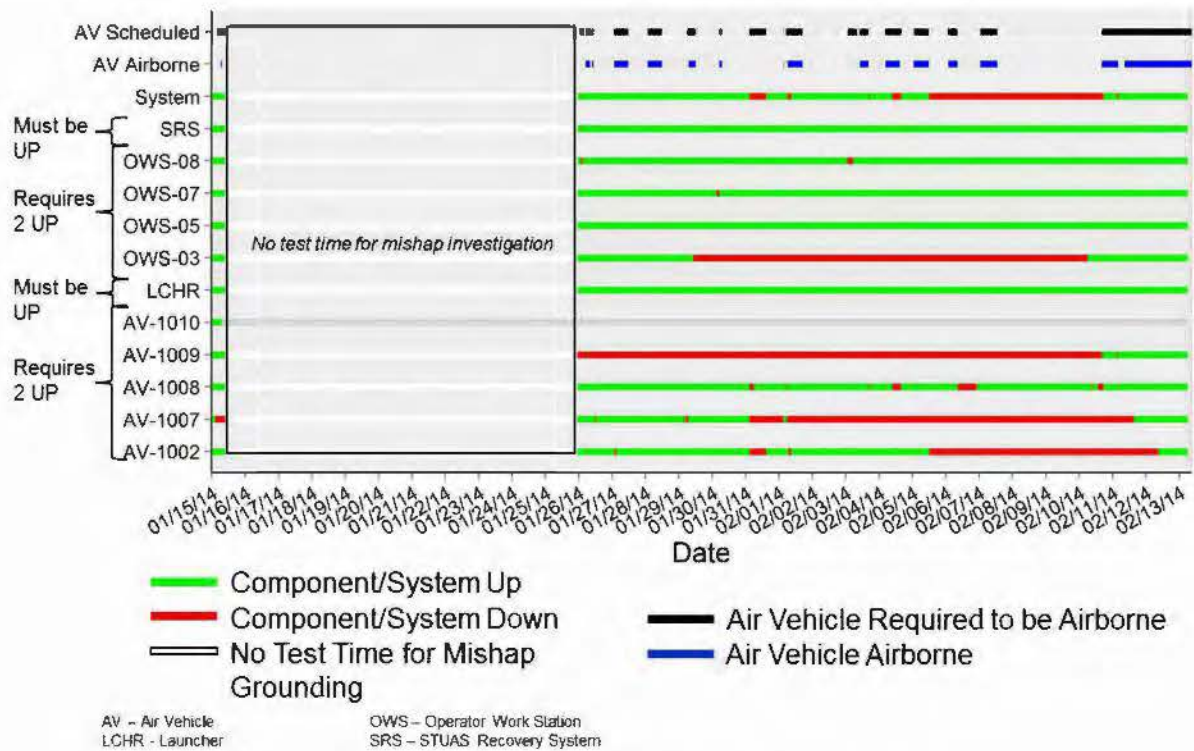
Figure 4-4. RQ-21A System Availability at Twentynine Palms

Figure 4-4 presents the status of each RQ-21A component during operations at Twentynine Palms. The period between the January 15 air vehicle mishap until the morning of January 26, 2014 is not counted in the availability calculation. During this period, the Marine Corps suspended flight operations pending the outcome of the mishap investigation.

A lack of air vehicles caused 148 of the 148.5 total system down hours. During those 148 hours, the system did not have the minimum two mission-capable air vehicles. The STUAS Recovery System accounted for the remaining 0.5 hours of system down time. Operator workstations and the launcher did not account for any system down time.

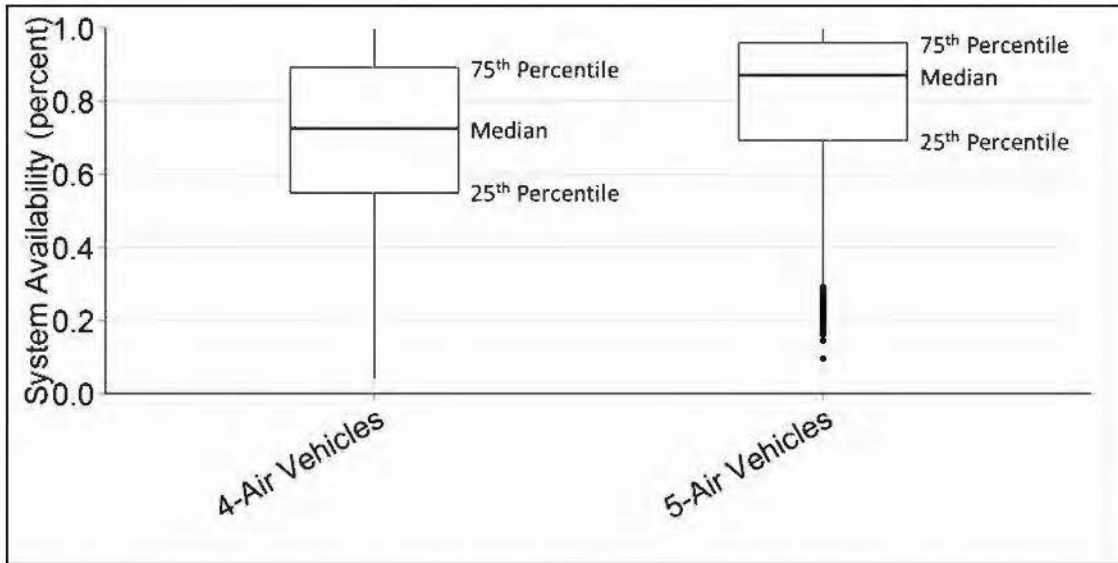
**Figure 4-5. Distribution of Bootstrap Availability Results by Number of Air Vehicles**

The loss of Air Vehicle 1010 on the first IOT&E flight without replacement adversely affected system availability. Instead of five air vehicles being available to make the two mission-capable air vehicles system requirement, the mishap left the system with four air vehicles to make two mission-capable air vehicles system requirement, thereby reducing built-in system redundancy. To assess the impact of the loss of Air Vehicle 1010 without replacement, DOT&E notionally included a fifth aircraft as if it were available for operations and conducted a bootstrap analysis to compare system availability with four and five air vehicles to account for the loss of air vehicle 1010 for the duration of operations at Twentynine Palms. Bootstrapping is a resampling method that relies on random sampling with replacement. Bootstrapping allows assigning measures of accuracy (in this case confidence intervals) to sample estimates. 10,001 bootstrap data sets were generated by re-sampling the original data set of system up and down

times with replacement, generating a bootstrap distribution for System Availability. DOT&E derived confidence intervals based on the 10th and 90th percentiles of this availability bootstrap distribution. Figure 4-5 presents the results of this hootstrap analysis. There is more variability in the results with four air vehicles as shown by the dispersion of the distribution (length of vertical lines). Conversely, the hootstrapping results for five air vehicles demonstrates that there was a higher availability and lower variability (dispersion) as seen in the shorter vertical line length. The box plot for 5-Air Vehicles does include some outliers, symbolized as dots at the bottom of the figure, but the number is small and falls outside the line.<sup>3</sup>

Using the bootstrap methodology, system availability exceeded 80 percent for 39.6 percent of the four-air vehicle system iterations. For the five-air vehicle system, 61 percent of the bootstrap iterations exceeded the 80 percent availability threshold. While the presence of a fifth air vehicle might have allowed the system to demonstrate meeting the 80 percent availability threshold, it would not have done so with statistical confidence.

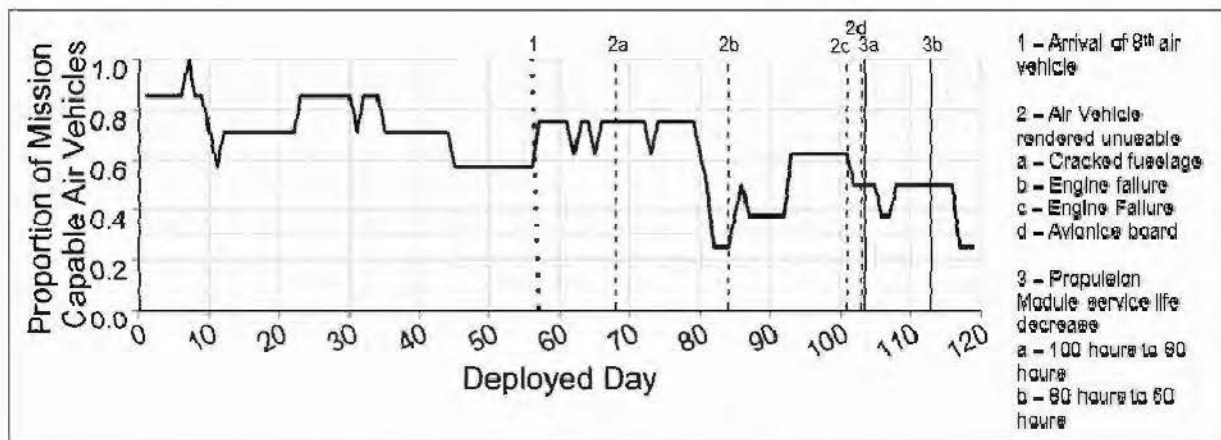
**Figure 4-7. Early Operational Capability Air Vehicle Availability**

Air vehicle availability was poor for the Early Operational Capability detachment. This detachment started operations with seven air vehicles, with an eighth air vehicle delivered on Day 57 of the deployment. As shown in Figure 4-7, after 119 days, the Early Operational Capability detachment had two mission-capable air vehicles (25 percent). Four of eight air vehicles were beyond repair (one cracked fuselage, two in-flight engine failures, and one damaged fuselage power distribution board) and two air vehicles required propulsion modules. Of the two operable air vehicles, one had 8 hours remaining on its propulsion module unit and would then require a replacement, which the detachment did not possess.

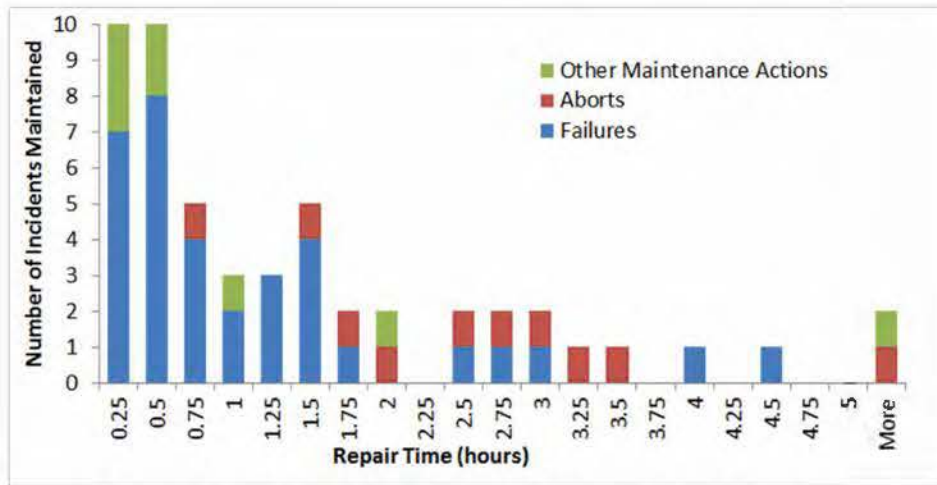
Figure 4-8. Distribution Twentynine Palms Repair Times

During the testing at Twentynine Palms, maintainers expended 65.1 hours repairing 44 failures.<sup>4,5</sup> The distribution of repair times is shown in Figure 4-8. Including the other maintenance actions, the total unscheduled maintenance time was 77.7 hours. Maintainers and field service representatives spent an additional 246.9 hours conducting scheduled and pre- and post-flight maintenance. The total maintenance time expended was 324.6 hours. The maintenance man hour per flight hour is 1.7 hours (324.6 hours/188.3 hours). The unscheduled maintenance man hour per flight hour is 0.41 (77.7/188.3). Assuming a lognormal distribution, the mean time to repair is 1.66 hours [1.31-2.10]. The mean time to repair aborts is 3.92 hours [2.57 – 5.98].

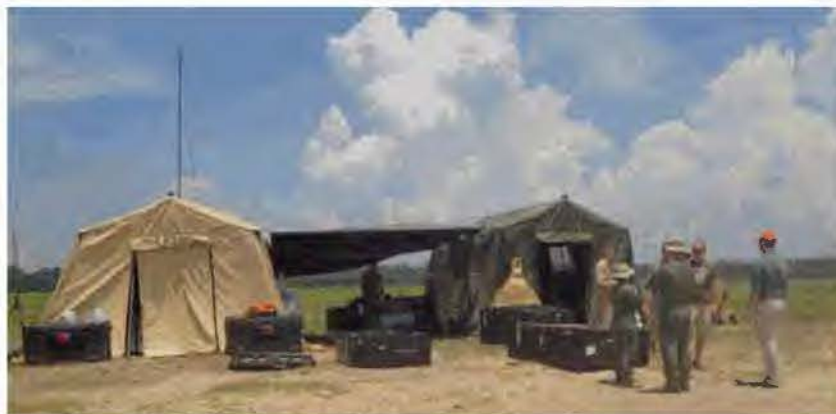
**Figure 4-9. RQ-21A Expeditionary Configuration**

RQ-21A support equipment does not facilitate expeditionary operations. As fielded, each RQ-21A system includes two tents used as shelter for the ground control stations. The system does not provide for inclement weather protection for air vehicles, support equipment, and spare parts. As shown in Figure 4-9, air vehicle module packing cases and spare parts would be stored under a tarpaulin strung between two tents or in the back of High Mobility Multipurpose Wheeled Vehicles (HMMWVs).
